Performance Evaluation of Stabilized Support Layers for Concrete Pavements

Research Report No. FHWA-ICT-22-003

ICT PROJECT R27-193-6

February 2022

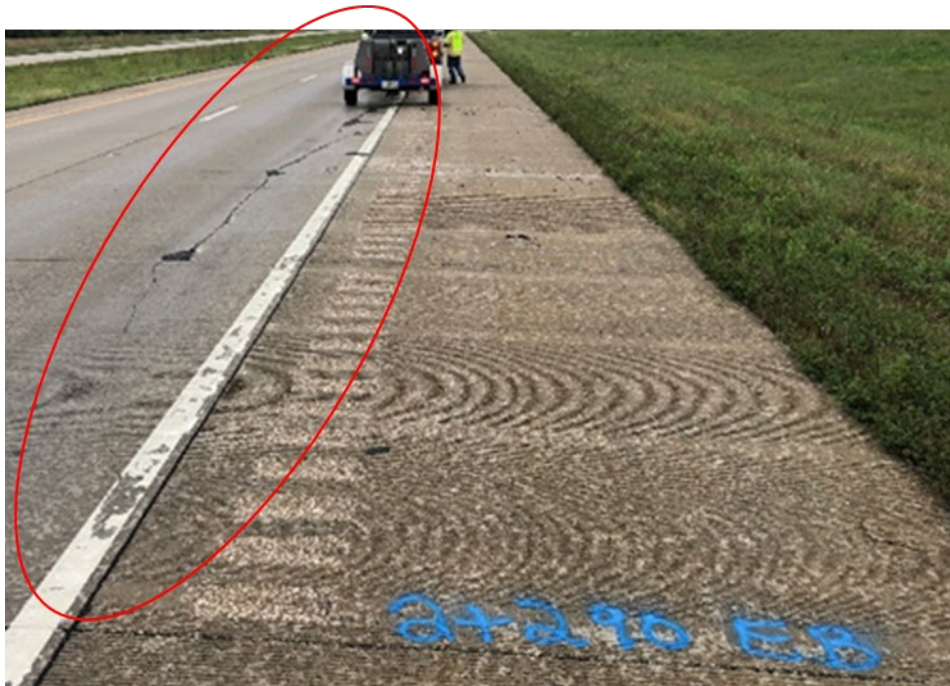
Figure S1. Photo. Loss of support beneath the concrete pavement on I-72 (92763).

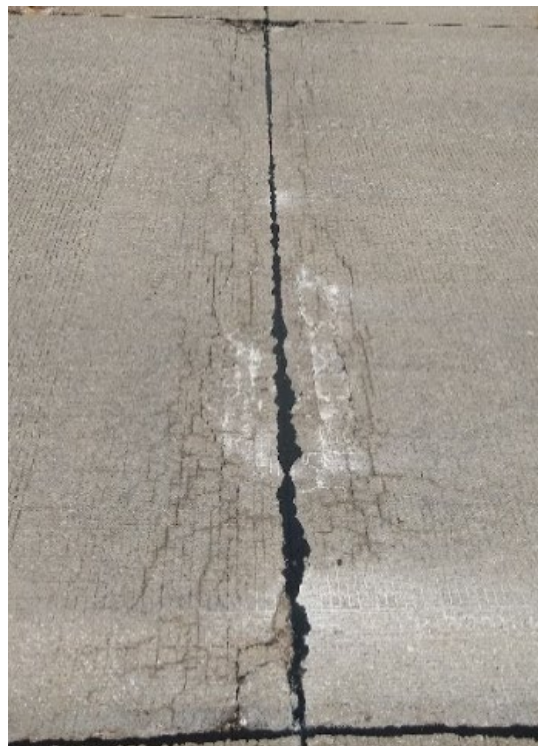
Figure 22. Photos. US 67 SB 23+839 distress at transverse joint.

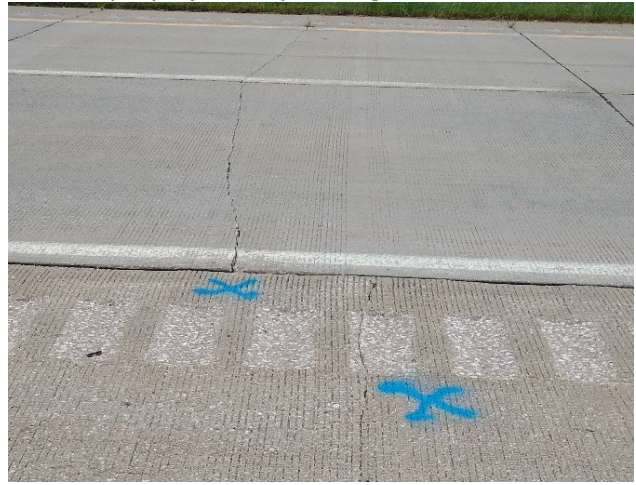
d) Transverse crack with spalling and faulting (26+498 SB)

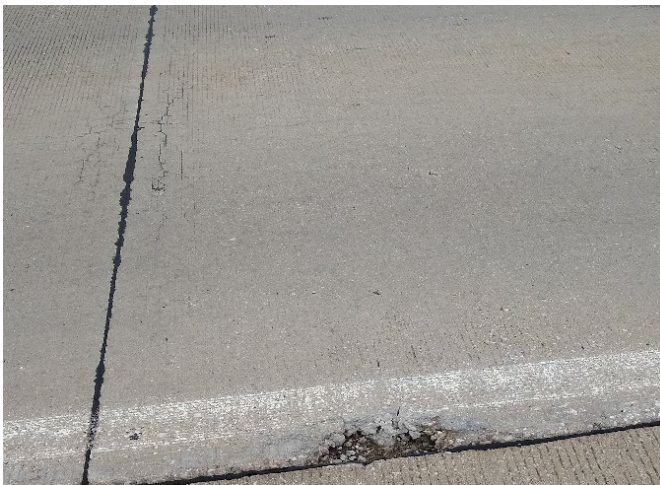
e) Longitudinal joint spalling and transverse joint deterioration (26+056 SB)

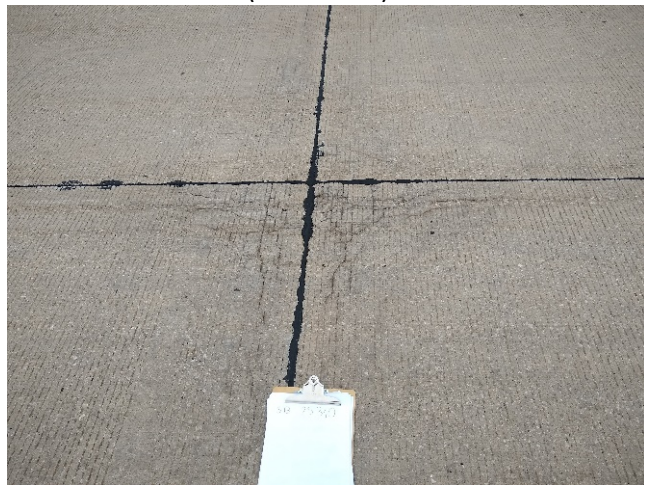
f) Corner distress in DL (25+340 SB)

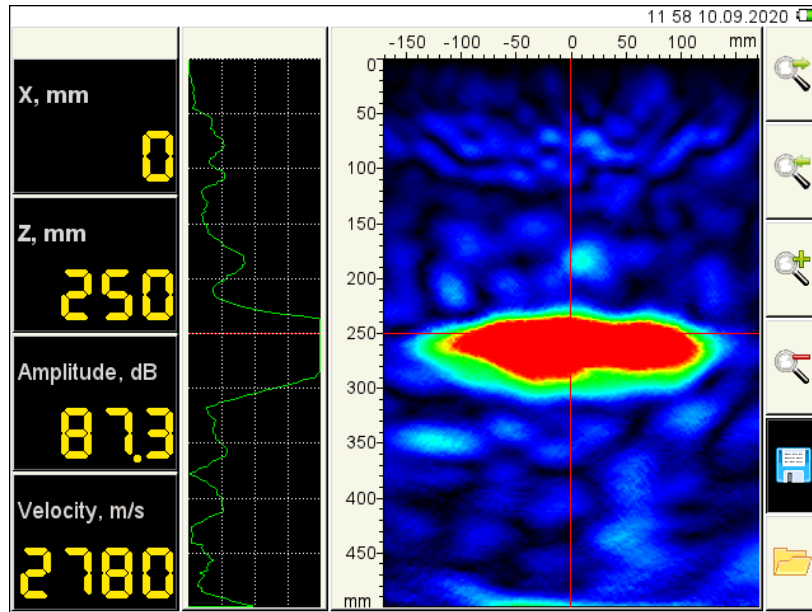
Figure 186. Image. US 67 SB MIRA B-scan with high intensity reflection (low degree of bond).

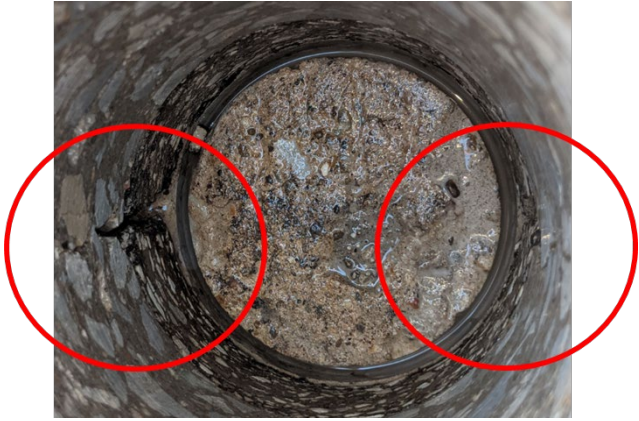
B. 14+02 EB OWP crack deterioration in HMA at transverse joint

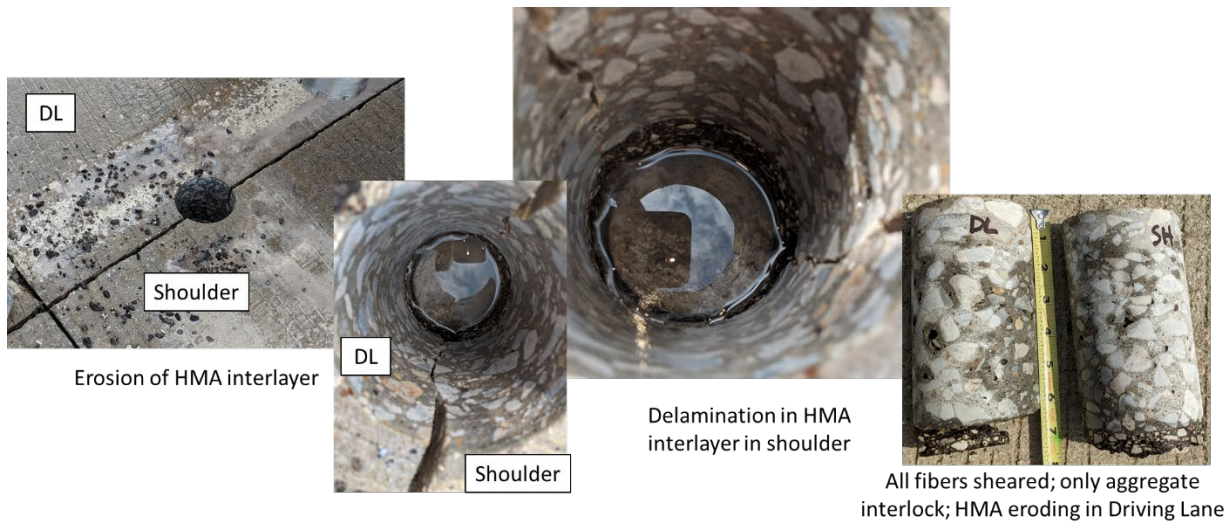
The coring results from directly over the lane-shoulder longitudinal joint also indicated stripping and erosion was occurring. The stripping and erosion at this location appears to be more severe than the transverse joint, as the HMA crumbled during coring (see **Figure 198**). Thicknesses of the HMA interlayer were not able to be determined based on the asphalt stripping and erosion. The magnitude of longitudinal lane-shoulder faulting has caused all fibers to shear, resulting in only aggregate interlock between interfaces. **Figure 198** shows the core location, inside the core hole, and the two halves of the core. It also appears as if there is some form of delamination within the HMA interlayer in the shoulder. It is difficult to determine if the shoulder is moving up a little, the driving lane moving down, or a combination of both.

Figure 198. Photos. Core over the longitudinal lane-shoulder joint from June 2021 (DeSantis and Roesler 2022).

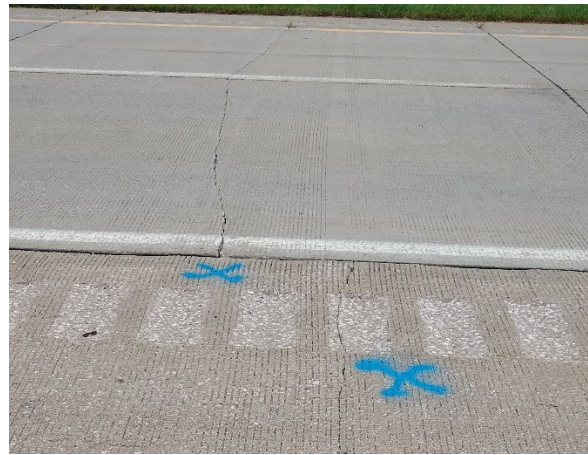
d) Transverse crack with spalling and faulting (26+498 SB)

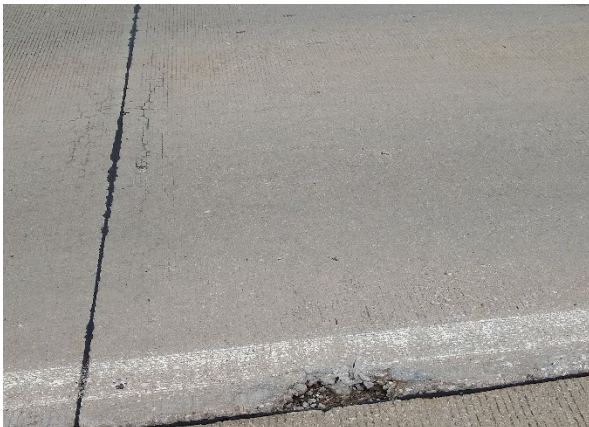
e) Longitudinal joint spalling and transverse micro-cracking along joint (26+056 SB)

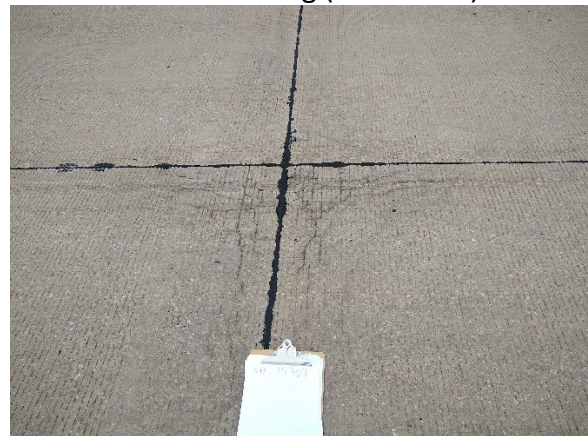
f) Corner distress in DL (25+340 SB)

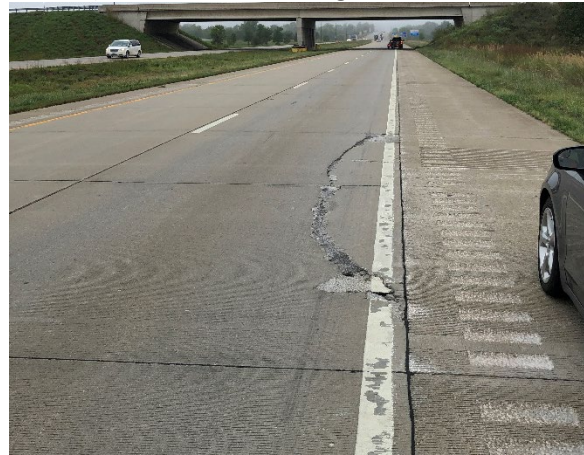
d) Edge failure due to lack of support (2+250 WB)

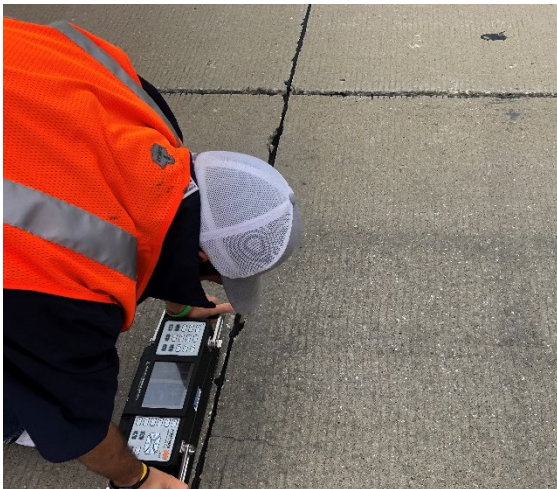
e) Longitudinal crack over dowel bar and longitudinal faulting (2+350 WB)

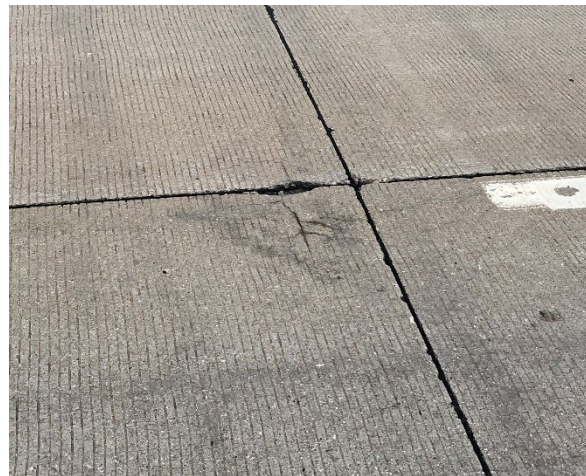
f) Corner failures (Section WB-2)

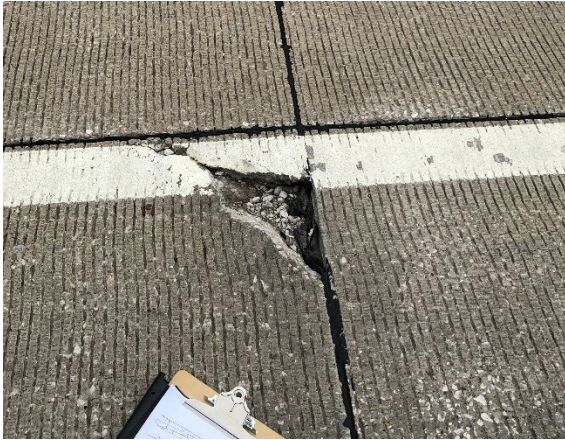
g) Corner failure with pop-out in DL between PL/DL (2+070 WB)

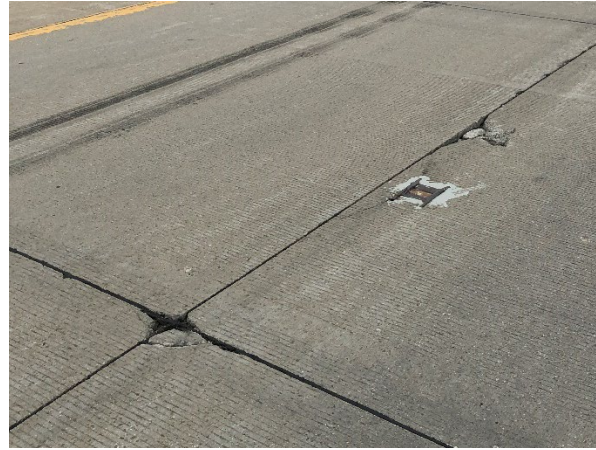
b) Corner distress in DL and Reflector damage (1+330 EB)

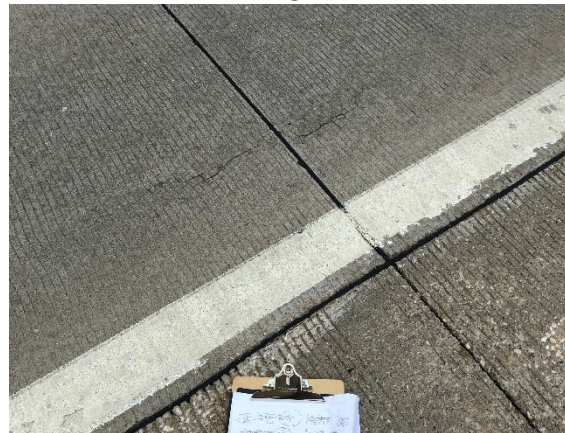
d) Longitudinal crack over dowel in OWP (2+140 EB)

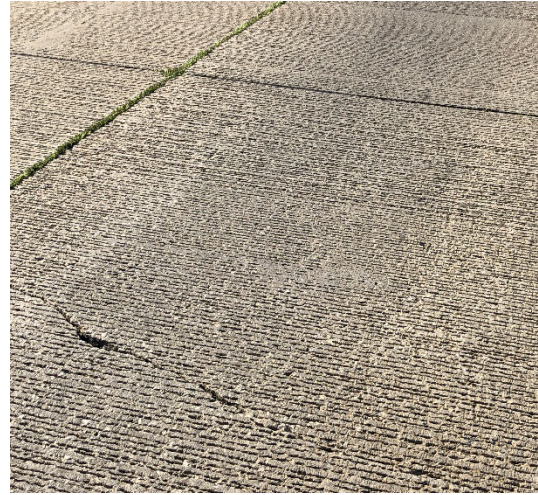
b) Trans. cracking and vegetation growth in long. jt. (897+60)

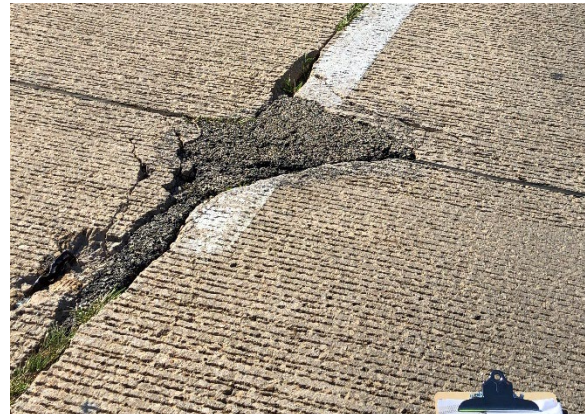
d) Long. jt. deterioration with HMA patch (901+00)

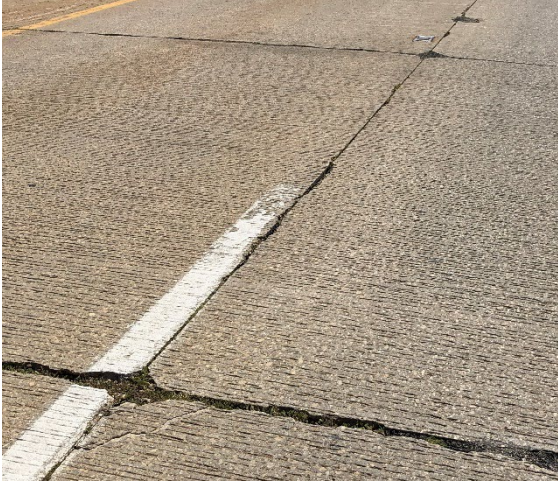
a) Joint deterioration (989+50)

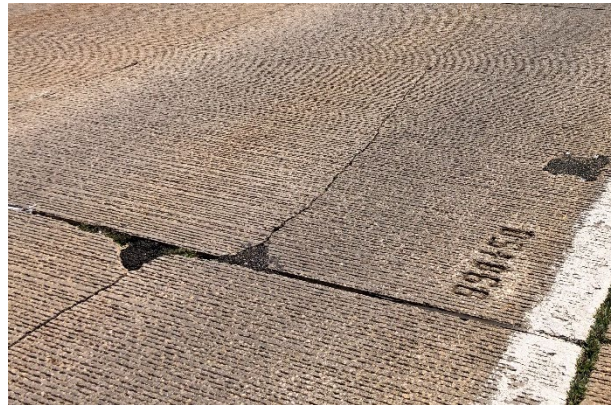
b) Mid-lane long. cracking in DL (998+50)

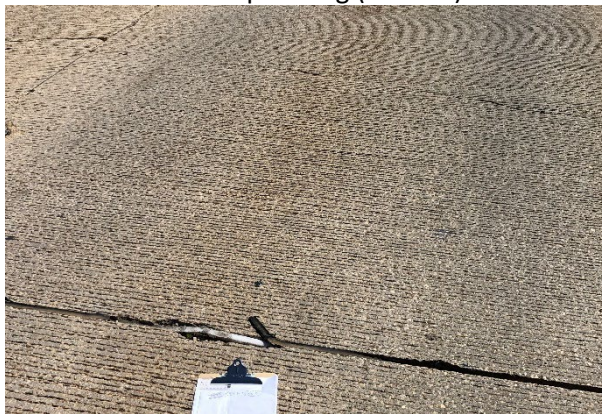
e) Mid-panel trans. cracking and jt. sealant damage (1001+15)

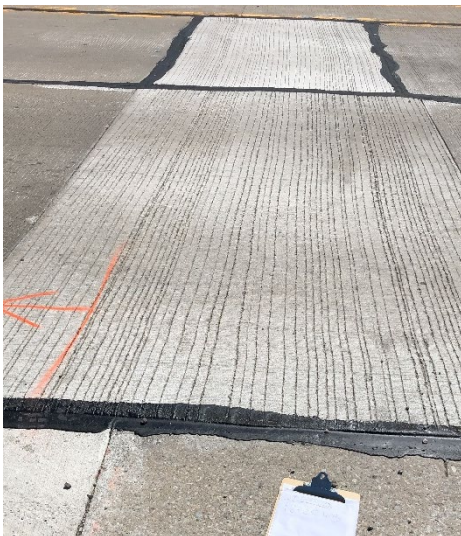
e) Full-depth repairs (12+25 WB)

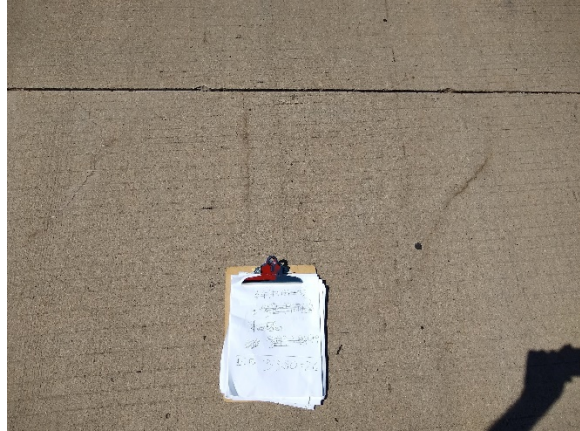
b) Longitudinal Cracking in DL on Leave slab near transverse joint (3380+26)

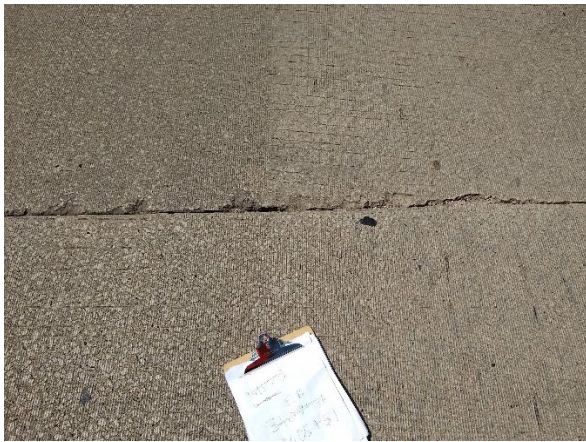
c) Joint spalling with corner spalling along Approach joint in DL (3405+51)

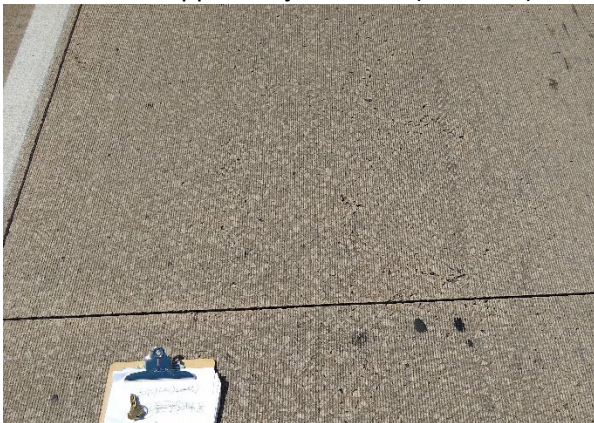
e) Poor consolidation in concrete surface – large voids (3405+96)

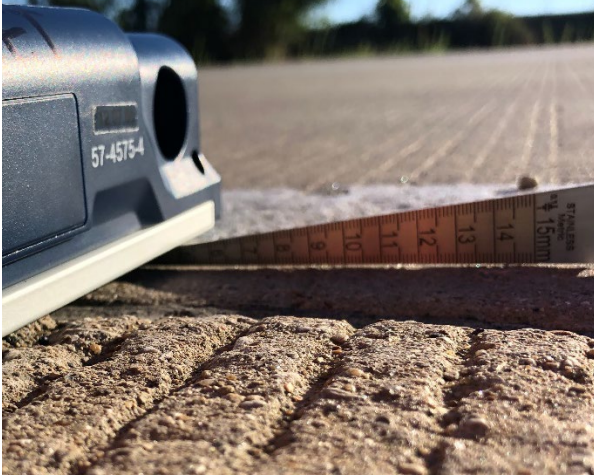
a) Long. joint faulting: Shoulder > DL (0.2 in.) – (277+82 to 276+00 SB)

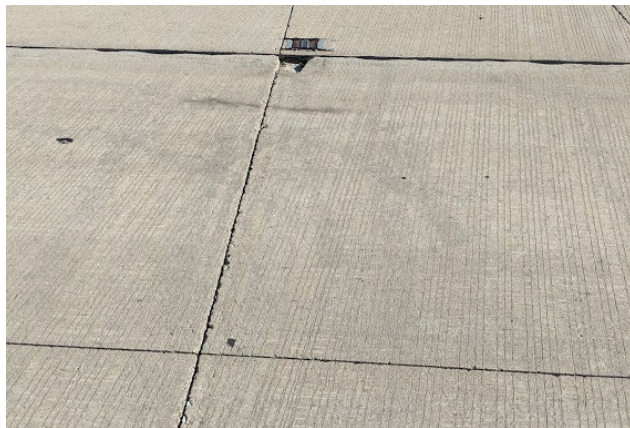
a) Long. cracking in the inner wheel path

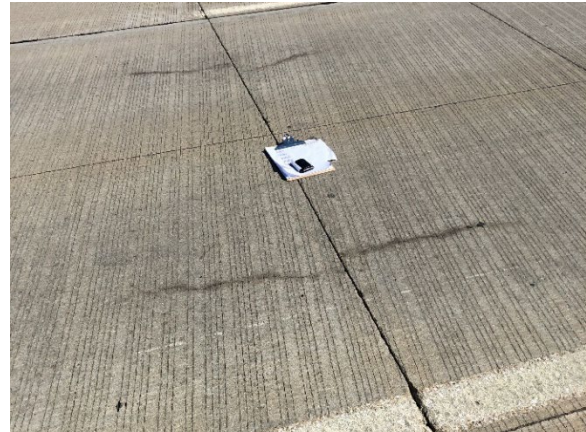
b) Long. cracking in both wheel path (inner and outer)

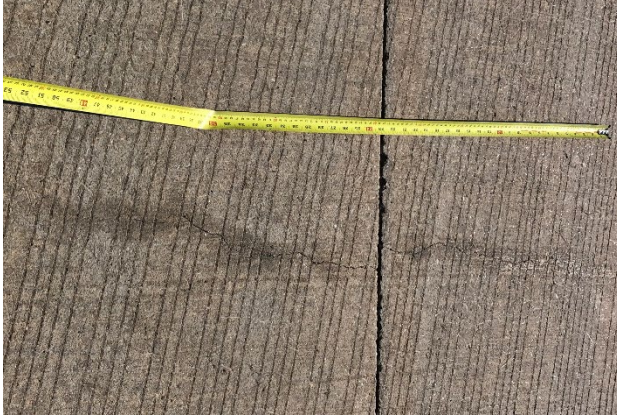
a) Length of long. crack (approx. 4 ft across the trans. jt.)

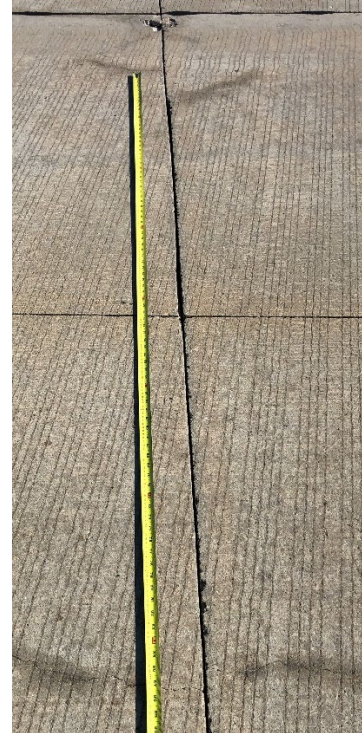
b) Distance between long. cracks at the trans. jt. (approx. 7.5-8 ft)

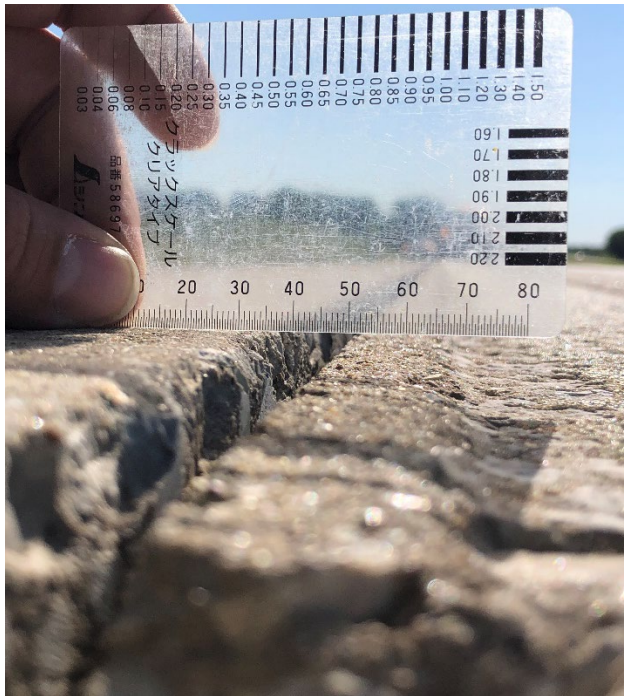
a) Lane/shoulder jt. elevation difference (shoulder = approx. 0.16 in [4 mm] higher than driving lane)

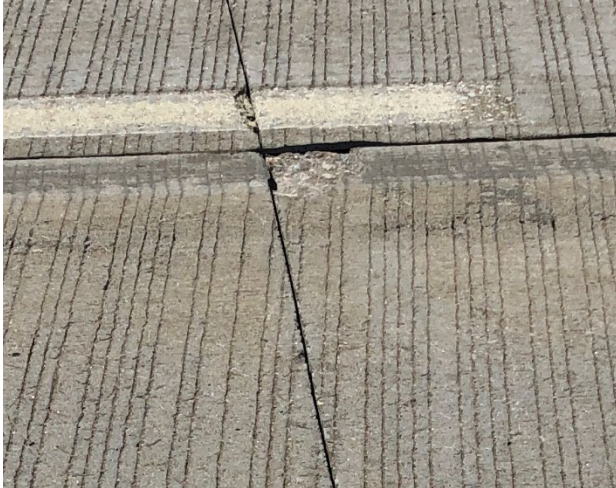
a) Corner distress on leave joint left panel in driving lane

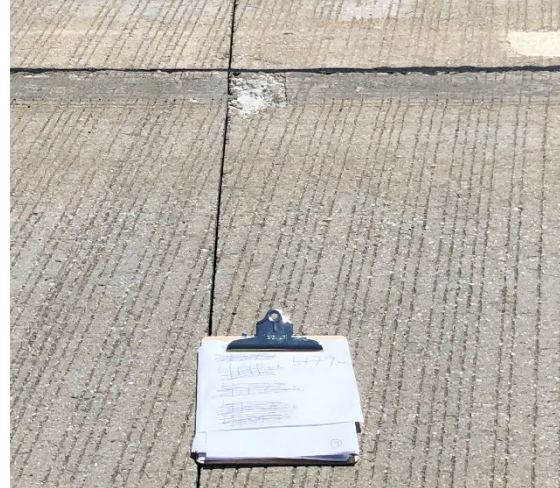
b) Corner distress on leave joint left panel in driving lane

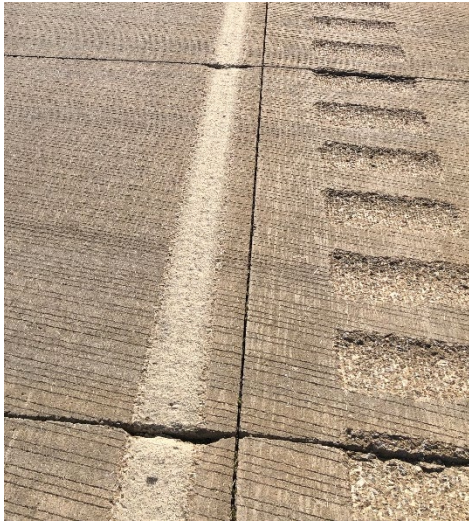
a) Milling of rumble strips effect on approach joint spalling

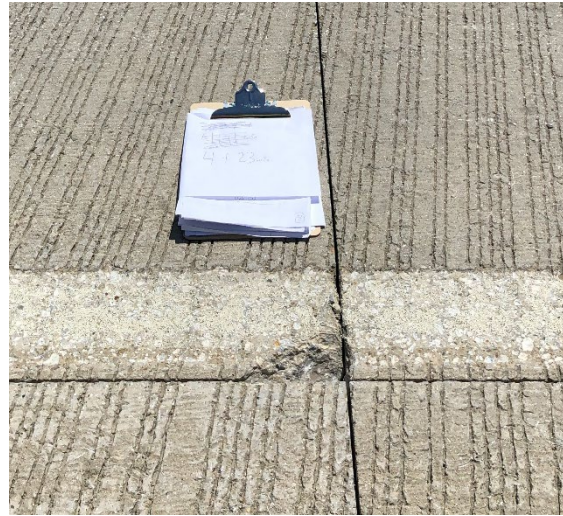
b) Milling of rumble strips effect on approach joint causing corner distress

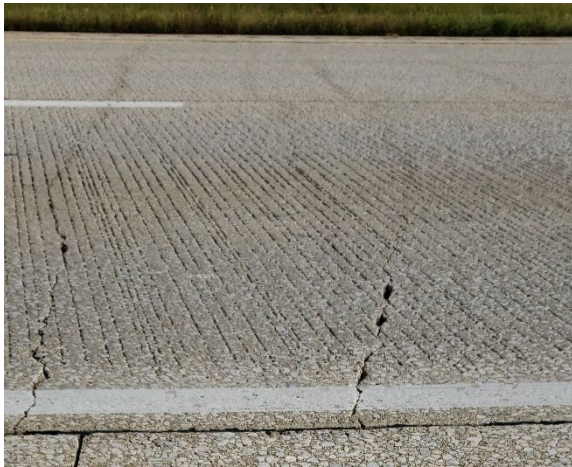
a) Y-crack (147+46 EB)

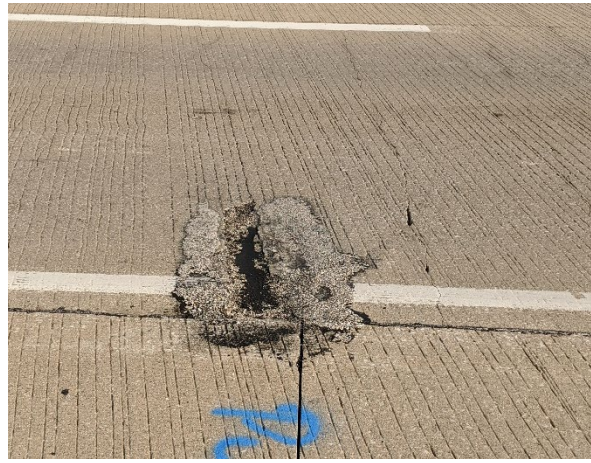
b) Punchout filled with HMA patch (247+35 EB)

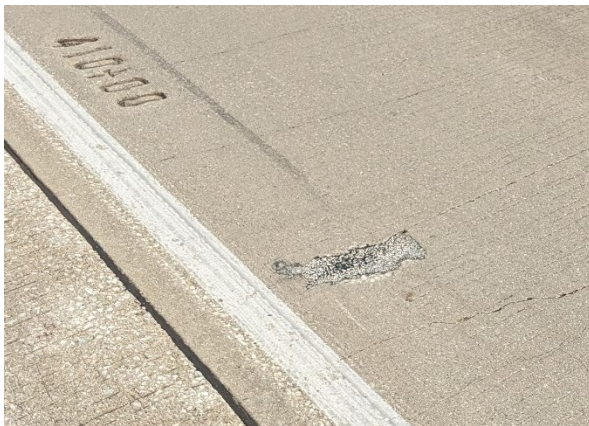
c) Small punchout (409+98 WB)

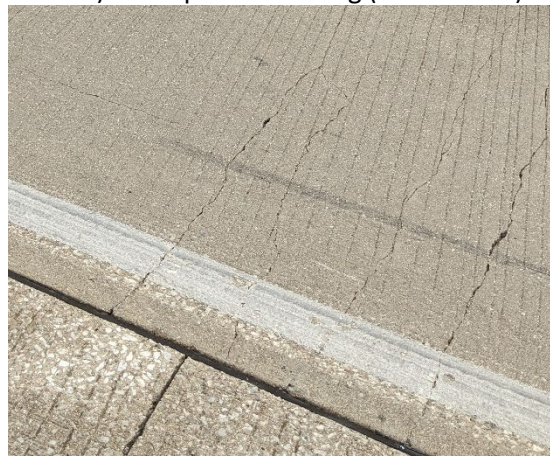
d) Y-cracking (409+96 WB)

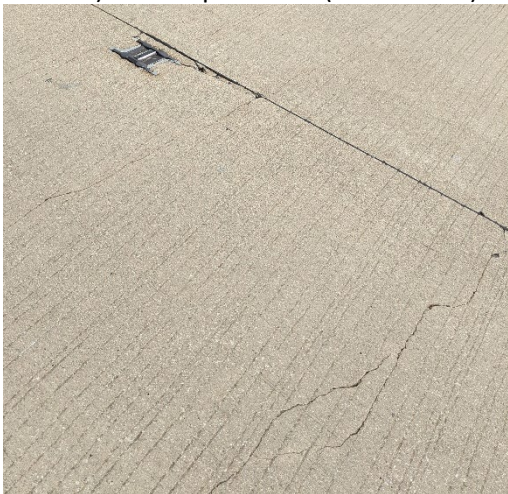
e) Reflector damage and Divided cracking
(Test Section WB-2)

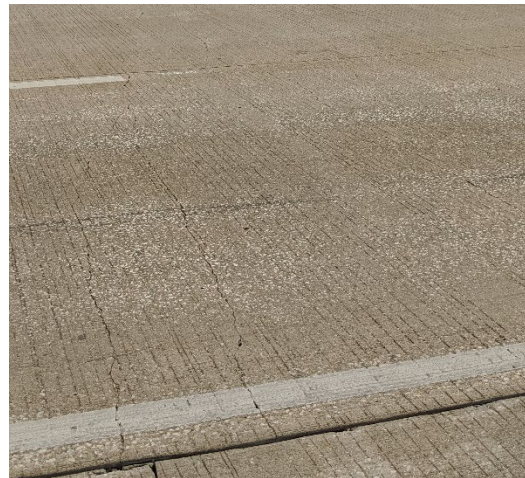
f) Y-cracking and complex Y-cracking (304+00
WB)

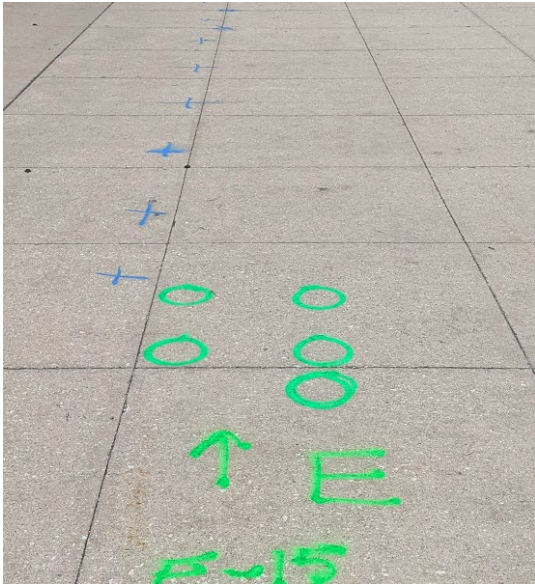
a) Surface scaling

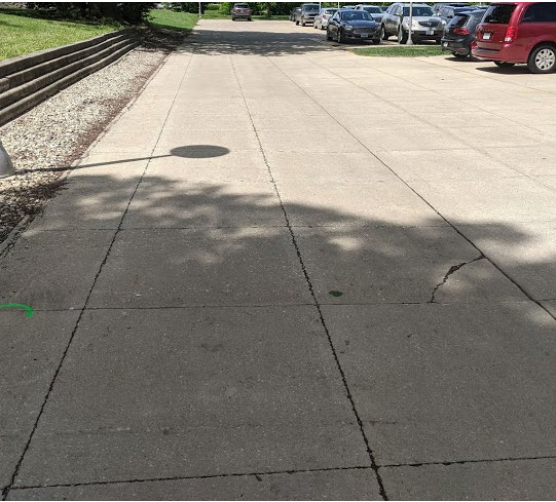
a) Corner break in southeast bay

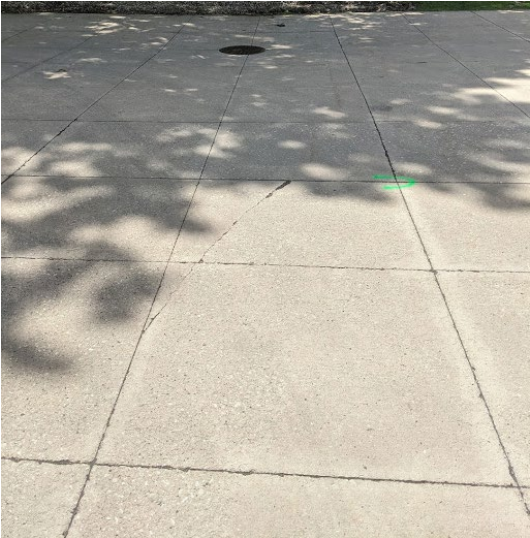
c) Diagonal cracking in northeast bay

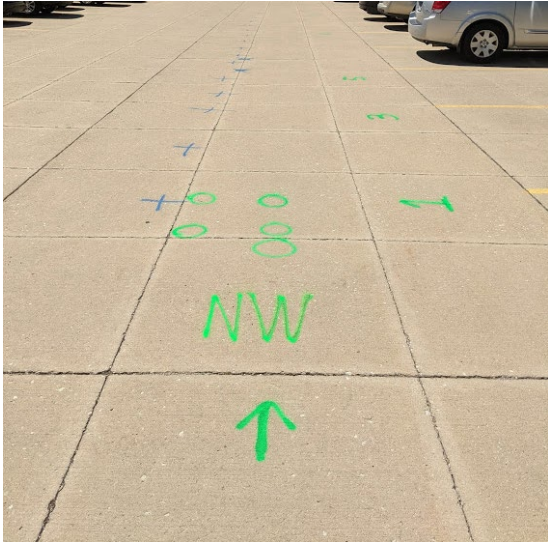
d) Joint raveling in northwest bay
