MULTI-HAZARD PERFORMANCE OF BRIDGE TIMBER PILES RETROFITTED WITH  
FIBER REINFORCED POLYMER COMPOSITES

DISSERTATION

Submitted in partial fulfillment of the requirements  
for the degree of Doctor of Philosophy in Civil Engineering  
in the Graduate College of the  
University of Illinois at Urbana-Champaign, 2018

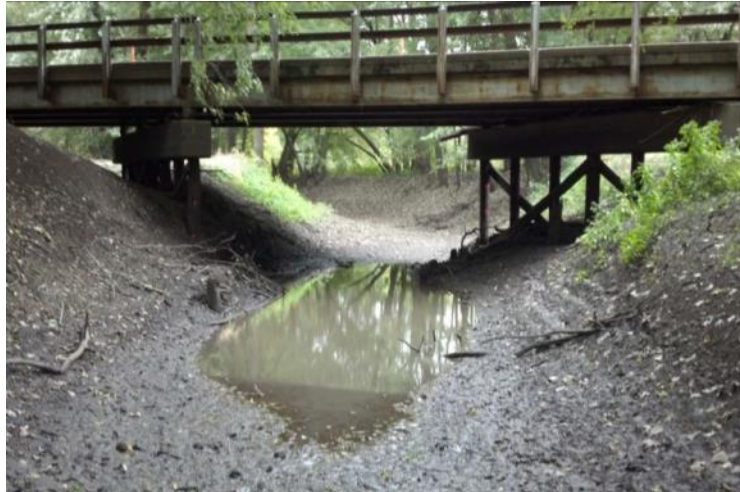
a)

**Figure 2.2** A typical timber pile bridge **a)** Bridge elevation **b)** Timber pile bent

In most timber pile bridges, timber usage is limited to the substructure with typically five to seven piles supporting the abutments and bents. The piles are driven with the larger cross-section in the natural taper of the timber as the head and are embedded in a reinforced concrete pile cap as shown in Figure 2.2 b). The particular bridge shown in Figure 2.2 consists of steel girders and a cast-in-place deck supported on timber pile bents and abutments. However, precast beam-slab systems are also commonly used.

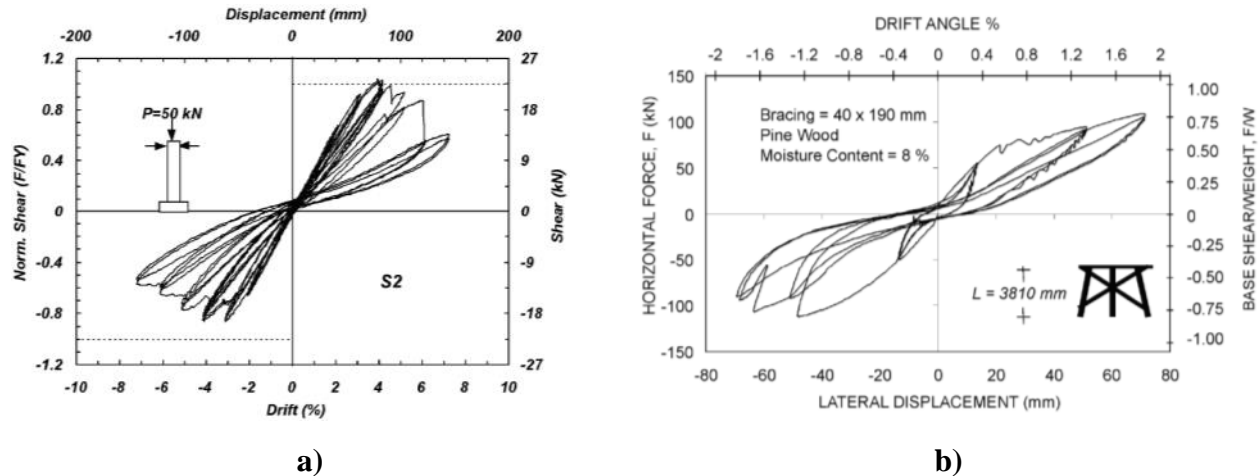
**Figure 2.8** Behavior of timber piles under cyclic lateral loading **a)** Single pile **b)**  $\frac{3}{4}$  scale timber pile bent (Shama et al. 2007)

In addition to a thorough literature review, the authors also carried out an extensive experimental program including quasi-static, cyclic lateral loading of single piles and model bents, as well as shaking table experiments on  $\frac{3}{4}$  scale timber pile bent models. The test results showed that timber pile bents behave in a very ductile manner with performance limited by the timber bending strength and condition in unbraced bents, and timber cross bracing in braced bents. Test results from Shama et al. (2007) demonstrating the behavior of timber piles under cyclic lateral loading are shown in Figure 2.8.

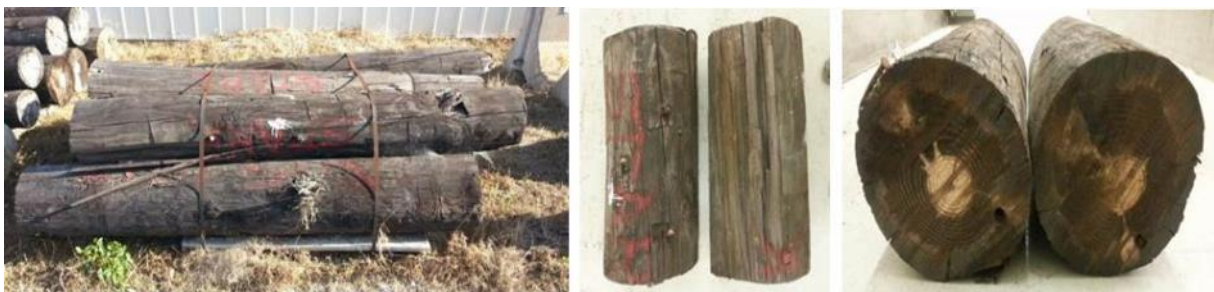
**Figure 3.1** Typical Red Oak pile specimens used in the study

In general, the outside surfaces of the piles showed signs of moderate weathering. Splitting ranging from a few millimeters wide up to a centimeter was noted throughout the specimens both along grain boundaries and across grains. Inspection of the specimen cross-sections revealed that although the overall level of creosote retention was high, in some specimens it had not fully penetrated to the core. Moderate to severe decay was observed in some piles which had led to section loss. The decay was typically limited to localized areas affecting only a few individual specimens. The moisture content of the specimens was determined through oven drying to be between 11 and 14%.

The piles used in this study ranged in diameter from 221 mm to 318 mm. While the exact age of the piles was not known, it was indicated that they were treated with creosote in 1993. Ports drilled for creosote injection were clearly visible and had been properly plugged. The piles were cut into specimens 610 mm in height. In total 24 specimens were prepared. Figure 3.1 shows typical timber specimens used in this study.

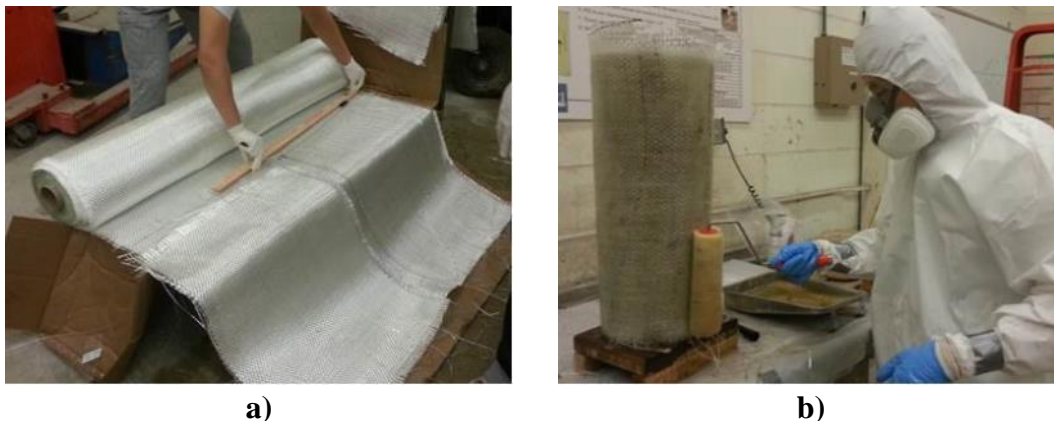
**Figure 3.2** FRP wet layup process **a)** cutting the fabric **b)** resin application

Prior to applying the FRP, the surfaces of the timber piles were cleaned with wire brushes to remove any dirt and debris. The fabric was cut into sheets tailored to each specimen then wrapped around the timber and saturated with resin using rollers. Each layer was overlapped three inches at the ends with each subsequent layer being offset by 90° to ensure that the seams did not coincide. The saturated FRP was smoothed out to remove any air pockets. The FRP was allowed to cure for at least 48 hours before testing. The FRP wet layup process is illustrated in Figure 3.2.

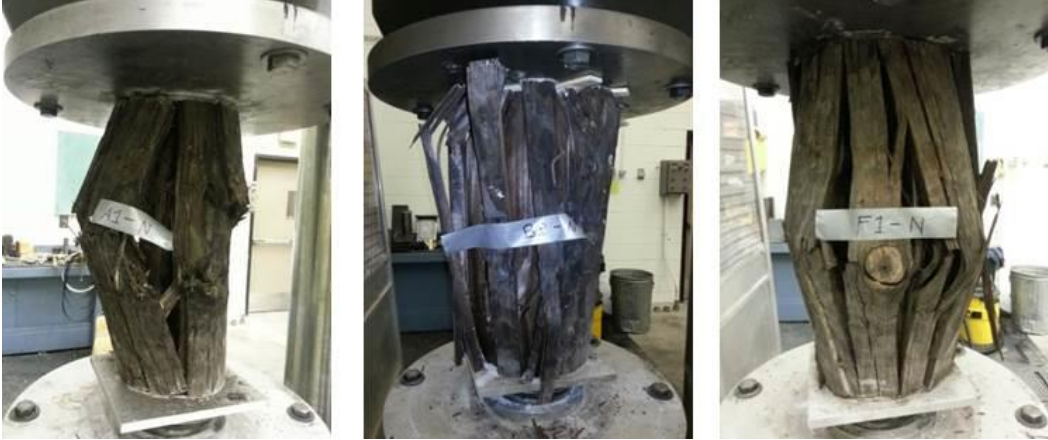
**Figure 3.5** Failure of unretrofitted timber specimens

crushing and buckling of the wood fibers. These failure patterns are illustrated in Figure 3.5. The stress-strain relationships observed in the unretrofitted timber specimens are shown in Figure 3.6.

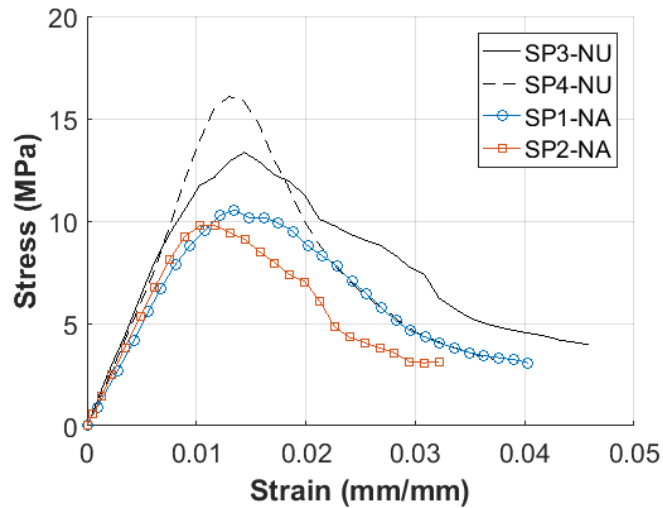
**Figure 3.9** Unretrofitted timber piles, as-is and after accelerated aging

unretrofitted specimens with and without accelerated aging are compared in Figure 3.9. From these results, it is clear that the accelerated aging leads to reductions in the strength.

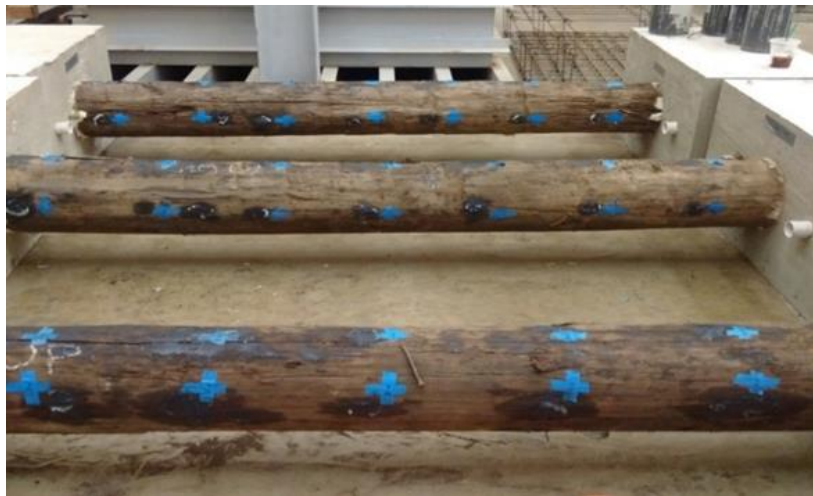
**Figure 4.1** Timber pile specimens used in experimental testing of FRP retrofits

The specimens were denoted SP1, SP2, and SP3. The average diameter of SP1 and SP3 was approximately 271 mm, and the average diameter of SP2 was 279 mm. The average density of the specimens was approximately  $740 \text{ kg/m}^3$ . Specimen SP3 was tested as-is to determine the baseline performance, while specimens SP1 and SP2 were retrofitted using FRP composites before testing. In order to gain an understanding of the internal condition of the piles and obtain a

Three Red Oak piles removed from service were used in the study. The timber pile specimens are shown in Figure 4.1. It was unclear how long these piles were in service and what service conditions they were exposed to. Nevertheless, visual inspection of the piles found no signs of decay or damage to the exterior of the specimens. Minor splitting was common across all three specimens. Red Oak is a common species of wood used as piles and railroad sleepers. Reference design values for Red Oak listed in the National Design Specification for Wood Construction (NDS) are shown in Table 3.1

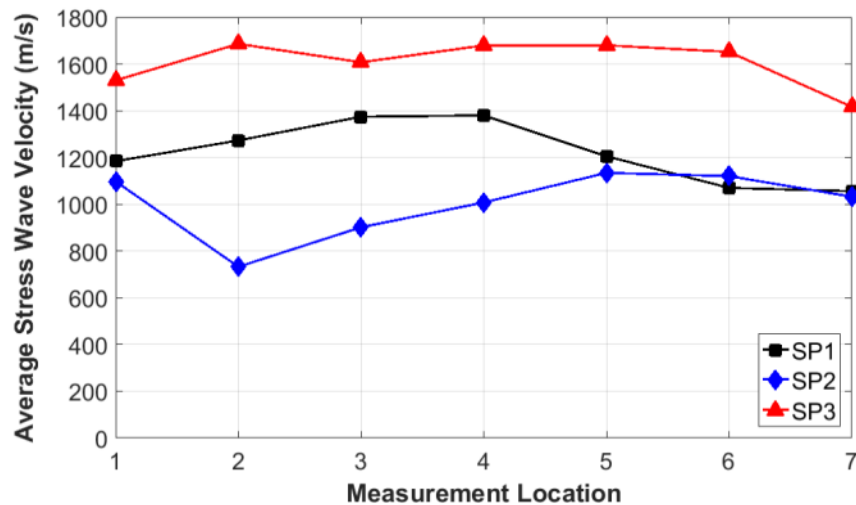
**Figure 4.2** Average stress wave velocity perpendicular to the grain along the pile length

In this study, the same UPV instrument used in Chapter 3 was used to take six cross-sectional stress wave velocity measurements at seven equally spaced locations along the length of each of the three piles. Although the number of measurements was not sufficient to develop a detailed tomographic image of the cross-section, the values provided a good indication of the internal condition and a standard for comparing the three specimens. The average stress wave velocity at each cross-section along the length is plotted in Figure 4.2. A constant input stress wave frequency of 54 kHz was used for all measurements.

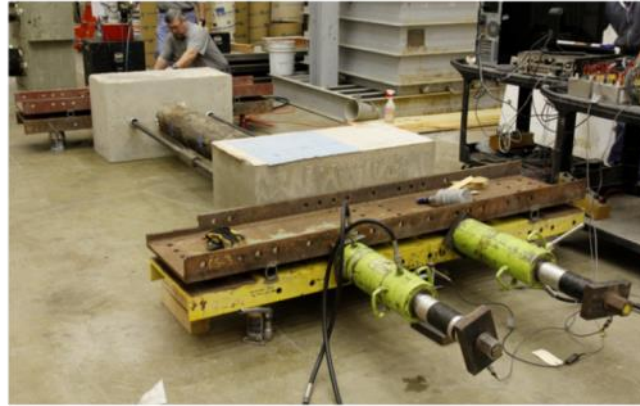
**Figure 4.5** Combined axial-bending interaction setup used in testing the piles

As shown in Figure 4.5, back-to-back MC18×58 (AISC designation) steel sections were used on top of the pile-caps to prevent the piles from punching through. Two 38 mm diameter post-tensioning rods were fitted through the C-channels and pile-caps 305 mm away from the pile centerline on either side. The tests were conducted by first imposing a constant bending moment then applying a concentric axial force. The bending moment was induced by tensioning only one of the rods using a bolt stretcher. Once the desired bending moment is reached, the eccentric load was anchored off and both rods were then tensioned simultaneously from the opposite end using two hydraulic jacks. The concentric load was increased until the onset of nonlinear behavior. Each pile was tested up to the elastic limit under eccentric loads varying from 44.5 kN up to 155.7 kN in 22.2 kN increments. The forces applied on the piles were

monitored using load cells. As shown in Figure 4.5, strains in the timber and FRP were measured at the extreme pile fibers at quarter and mid-length, and linear variable displacement transducers (LVDTs) were placed at the ends of the pile-caps to measure the total axial deformations. The tests were conducted with the timber piles lying horizontally. The interface between the pile caps and the floor was lubricated with form oil in order to minimize friction.

Experimental tests on timber piles under eccentric loading by Borello et al. (2010) showed that the presence of bending significantly reduces the axial capacity of the piles. Abutment timber piles are generally loaded concentrically in the axial direction but lateral loads imposed by earth pressure and surcharge loads generate bending moments. Based on a survey conducted on several existing timber pile bridges, it was decided to cut the specimens to a total length of 2,744 mm and have the two pile ends embedded 305 mm in reinforced concrete pile caps to facilitate the application of both axial and bending concurrently. To apply combined bending and axial loads to the pile specimens the post-tensioning scheme shown in Figure 4.5 was used.

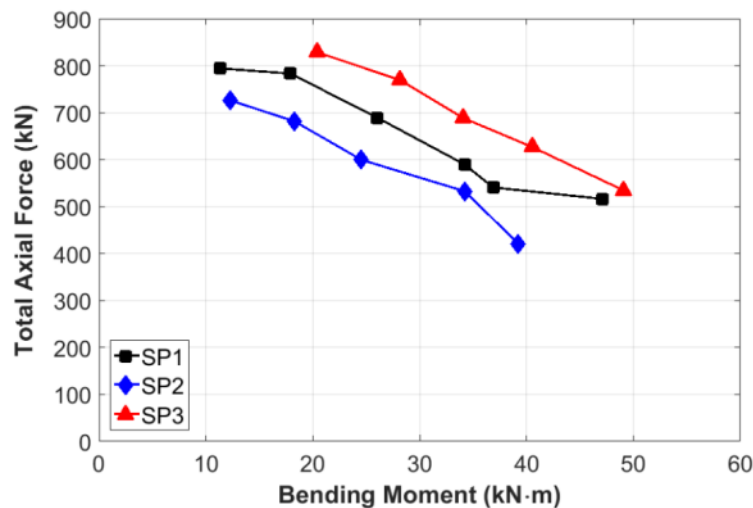
**Figure 4.7** Peak total axial force attained under each bending moment

As can be seen, the curvature caused by the eccentric loads followed the same pattern for all three specimens. Compared to the unretrofitted specimen SP3, the curvatures in the retrofitted specimens SP1 and SP2 were 4% and 11% higher on average, respectively. This suggests that despite the additional stiffness provided by the FRP retrofit, the behavior is still strongly influenced by the timber pile condition. After each loading scheme, the specimens were fully unloaded and visually inspected. However, there was no visible damage to the timber piles or the FRP composite even at very high loads. The cracking of the FRP heard during testing was most likely from the resin as no visible fiber fractures were noted. Furthermore, there was no evidence of bond failure between the timber piles and FRP composites. The ultimate P-M interaction behavior is plotted in Figure 4.7.

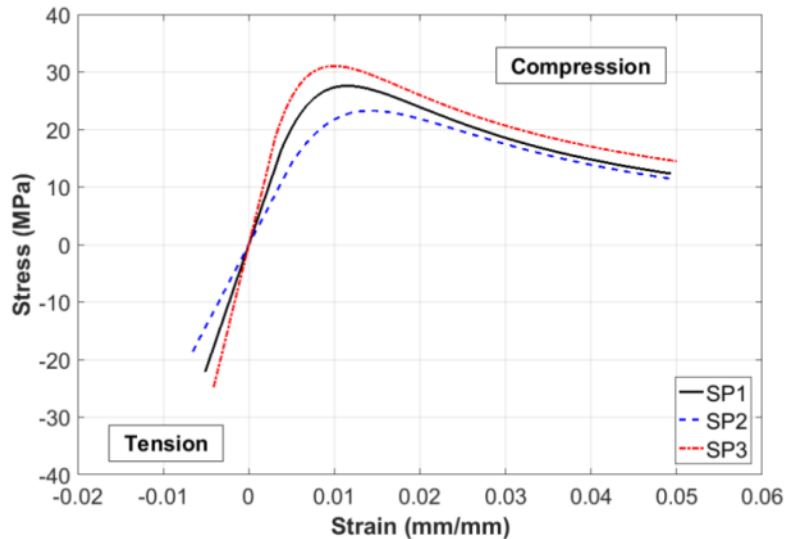
**Figure 4.10** Timber stress-strain behavior calibrated from the experimental results

experimental test results, timber material models for SP1, SP2, and SP3 were calibrated. The timber stress-strain behavior adopted in the FE model is shown in Figure 4.10.

Compared to SP3, the elastic moduli of SP1 and SP2 were lower by 28% and 53%, respectively. The material models shown in Figure 4.10 are indicative of the stress wave timing results which showed that the timber piles in SP1 and SP2 were in much more deteriorated conditions compared to SP3. Figure 4.11 presents relationships between the dynamic moduli obtained from SWT for each specimen and the elastic moduli and peak compressive stress of the specimens. There appears to be a clear linear correlation between timber material properties and the dynamic modulus. These observations by no means constitute conclusive evidence of a relationship between timber material properties and dynamic modulus given the small sample size considered in this study. However, more detailed studies in this area would be beneficial for many different structural engineering applications.

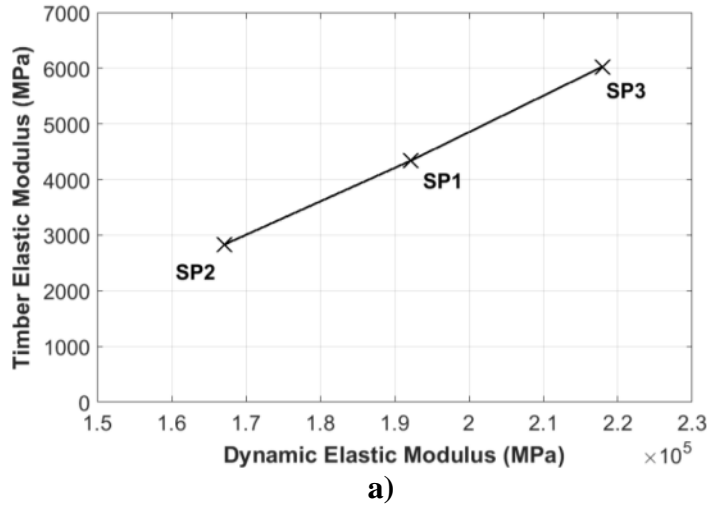
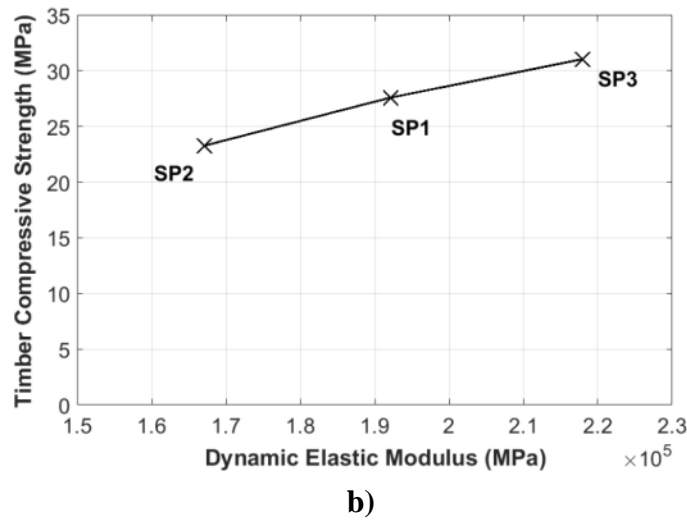
**Figure 4.11** Calibrated timber pile material elastic modulus **a)** and compressive strength **b)** compared to dynamic elastic moduli computed from SWT measurements

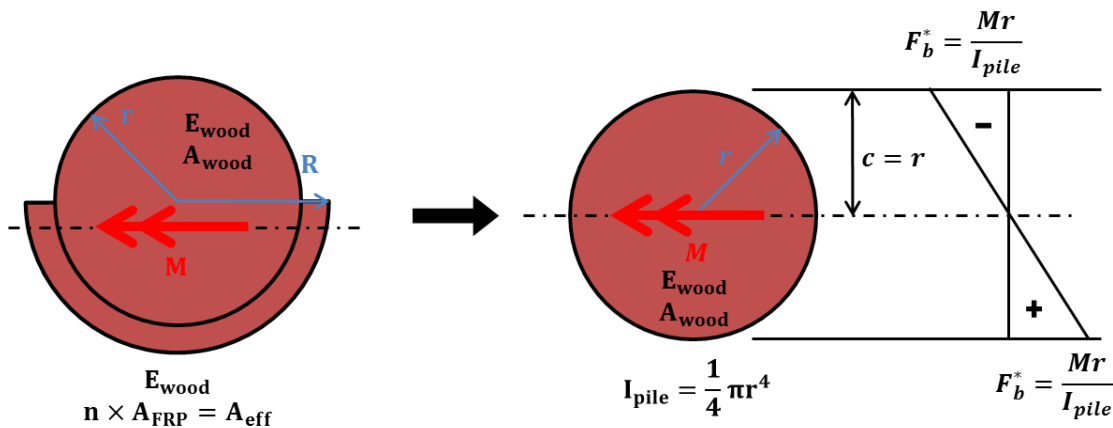
**Figure 5.4** Projection of the bending moment obtained from transformed section analysis onto an unretrofitted timber pile section

where,  $M$  is the bending moment capacity of the retrofitted section,  $E_{wood}$  is the timber pile elastic modulus,  $I_{eff}$  is the transformed section moment of inertia,  $c_{eff}$  is the distance from the extreme compressive fiber to the neutral axis, and  $\epsilon_{comp}$  is the elastic strain at the extreme compressive timber fiber under bending computed using the allowable bending stress  $F_b$  and  $E_{wood}$ . Using FRP composites as tensile reinforcement as in this case can improve the strength of timber piles in bending but it will not directly improve their capacity under pure axial loading. The improved bending moment capacity can be translated into a modified allowable bending stress  $F_b^*$  by projecting the moment onto an unretrofitted timber pile section as shown in Figure 5.4.

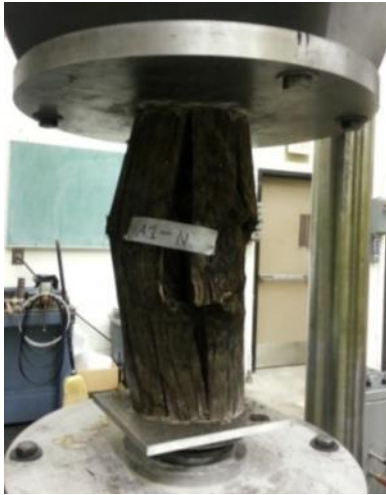
a)

To establish representative material models for this study, specimens were cut from a random selection of field-extracted round Red Oak piles and tested in uniaxial tension and compression. There was no information available on the service duration or site conditions for any of the piles but all specimens were treated with creosote and there were no visible signs of decay or other significant defects. For compressive behavior parallel to the grain, seven specimens were cut from different piles and tested under uniaxial compression. The compression specimens were 610 mm in length and ranged in diameter from 250 mm to 295 mm. For tensile behavior parallel to the grain, ten coupon specimens were fabricated and tested in accordance with ASTM D143-14 (ASTM 2014). At the time of testing, the moisture content of the specimens was between approximately 19% and 21%. The test specimens and results are shown in Figure 6.8.

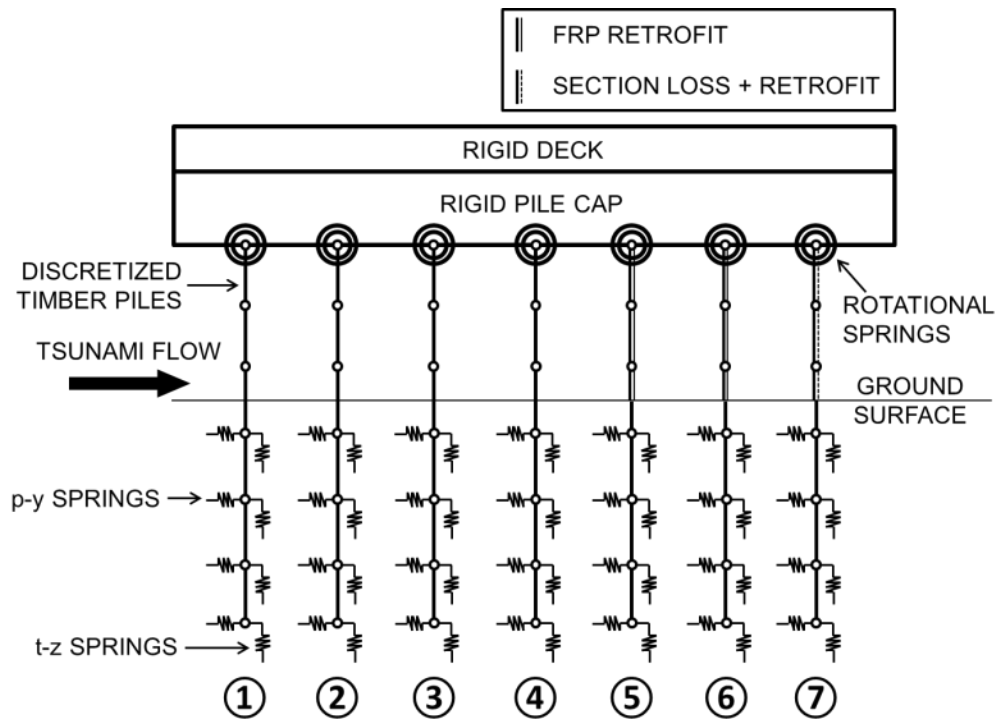
**Figure 6.11** Schematic of the timber pile bent model created in OpenSees

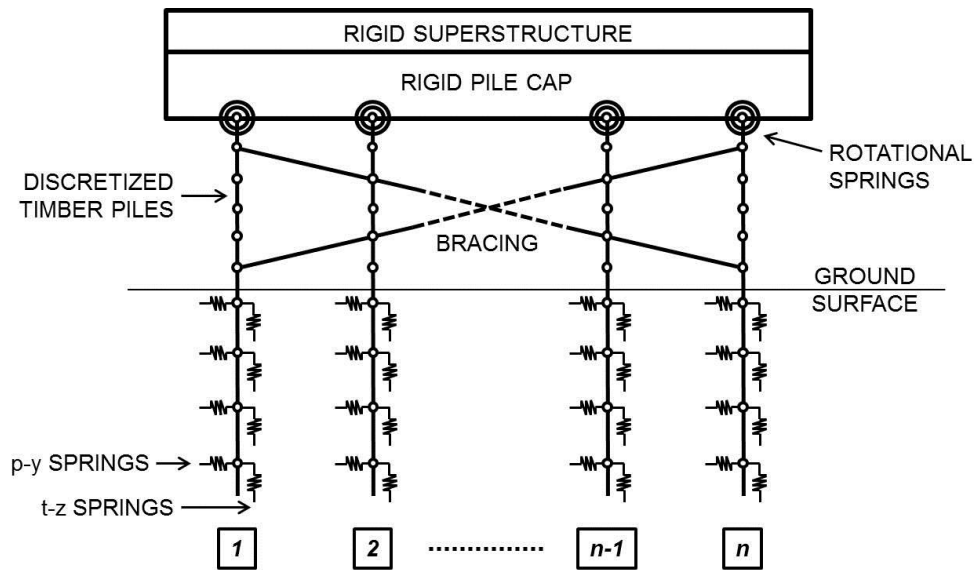
**Figure 7.3** Schematic of a timber pile bent numerical model
