FAILURE ANALYSIS OF A 30KHZ ULTRASONIC WELDING TRANSDUCER

THESIS

Submitted in partial fulfillment of the requirements
for the degree of Master of Science in Mechanical Engineering
in the Graduate College of the
University of Illinois at Urbana-Champaign, 2010

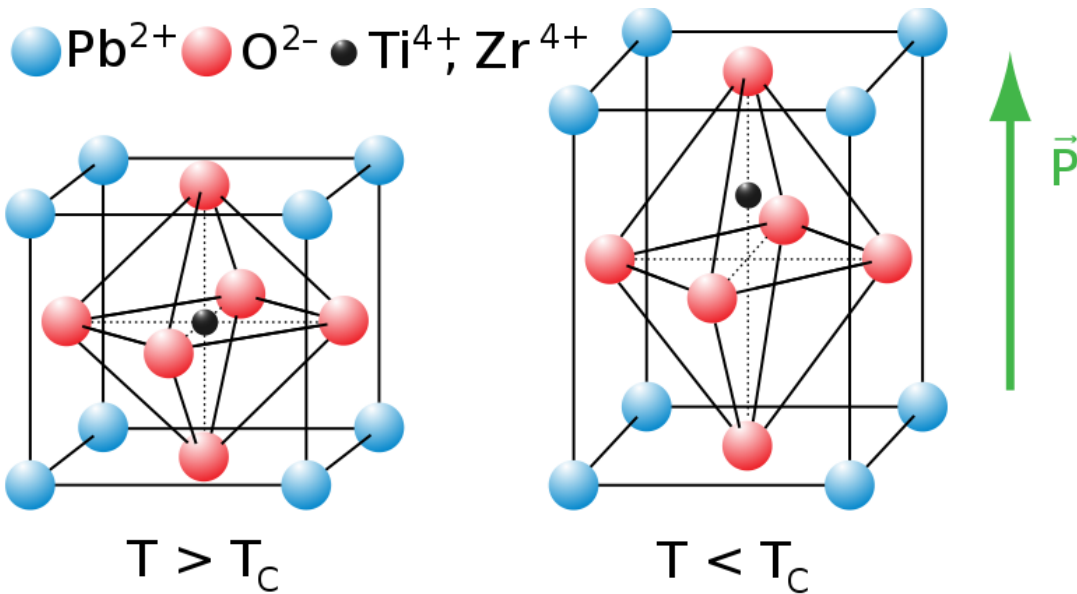
Figure 2.2 – Molecular structure of PZT above and below Curie temperature

The piezoelectric properties of PZT ceramics are a result of their molecular structure. The most useful piezoelectric properties are observed when the mole fraction of Ti and Zr are close to 0.5. $\text{PbZr}_{.47}\text{Ti}_{.53}\text{O}_3$ is a common configuration used in industry. Examining the phase diagram in figure 2.1, it is apparent that multiple crystalline structures can exist near this mole fraction. This transitional area is called the morphotropic phase boundary (MPB) [7]. Above the Curie temperature (T_c), the structure is cubic. At this point there is no net dipole due to cubic symmetry. However once the temperature drops below the Curie point, the structure becomes tetragonal or rhombohedral. It is this distorted structure that creates an electric dipole moment. These non-cubic structures have over 14 stable domain configurations at the MPB giving them great flexibility during polarization [7]. Figure 2.2 shows the structure above and below the Curie temperature.

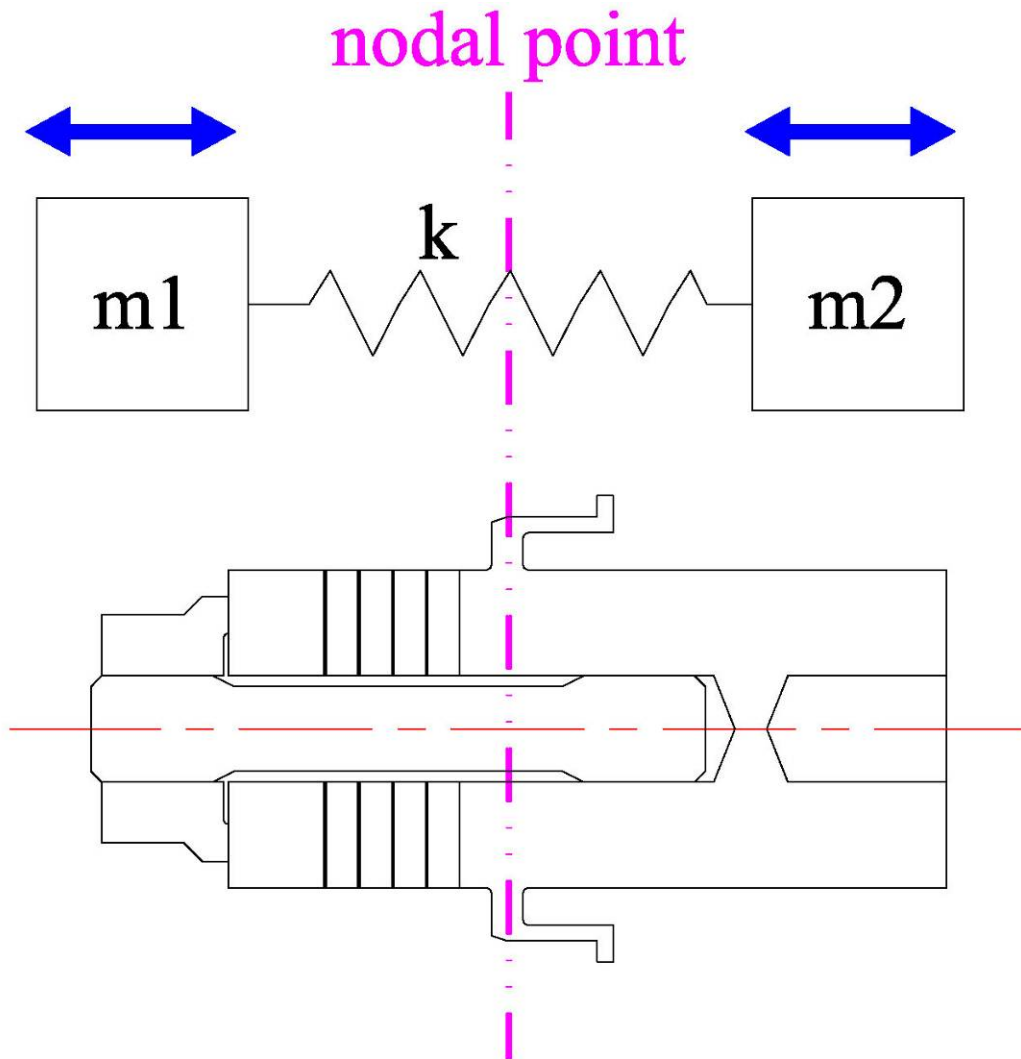
Figure 2.6 – mass-spring-mass transducer model

wave propagation, thermodynamics, electrostatics, crystallography and circuit theory [13]. This is due to all the interactions which are occurring during operation. Even though this device is very complex, we can still break it into smaller manageable pieces to study the basic operating principles and gain a general understanding with a few simple models [15].

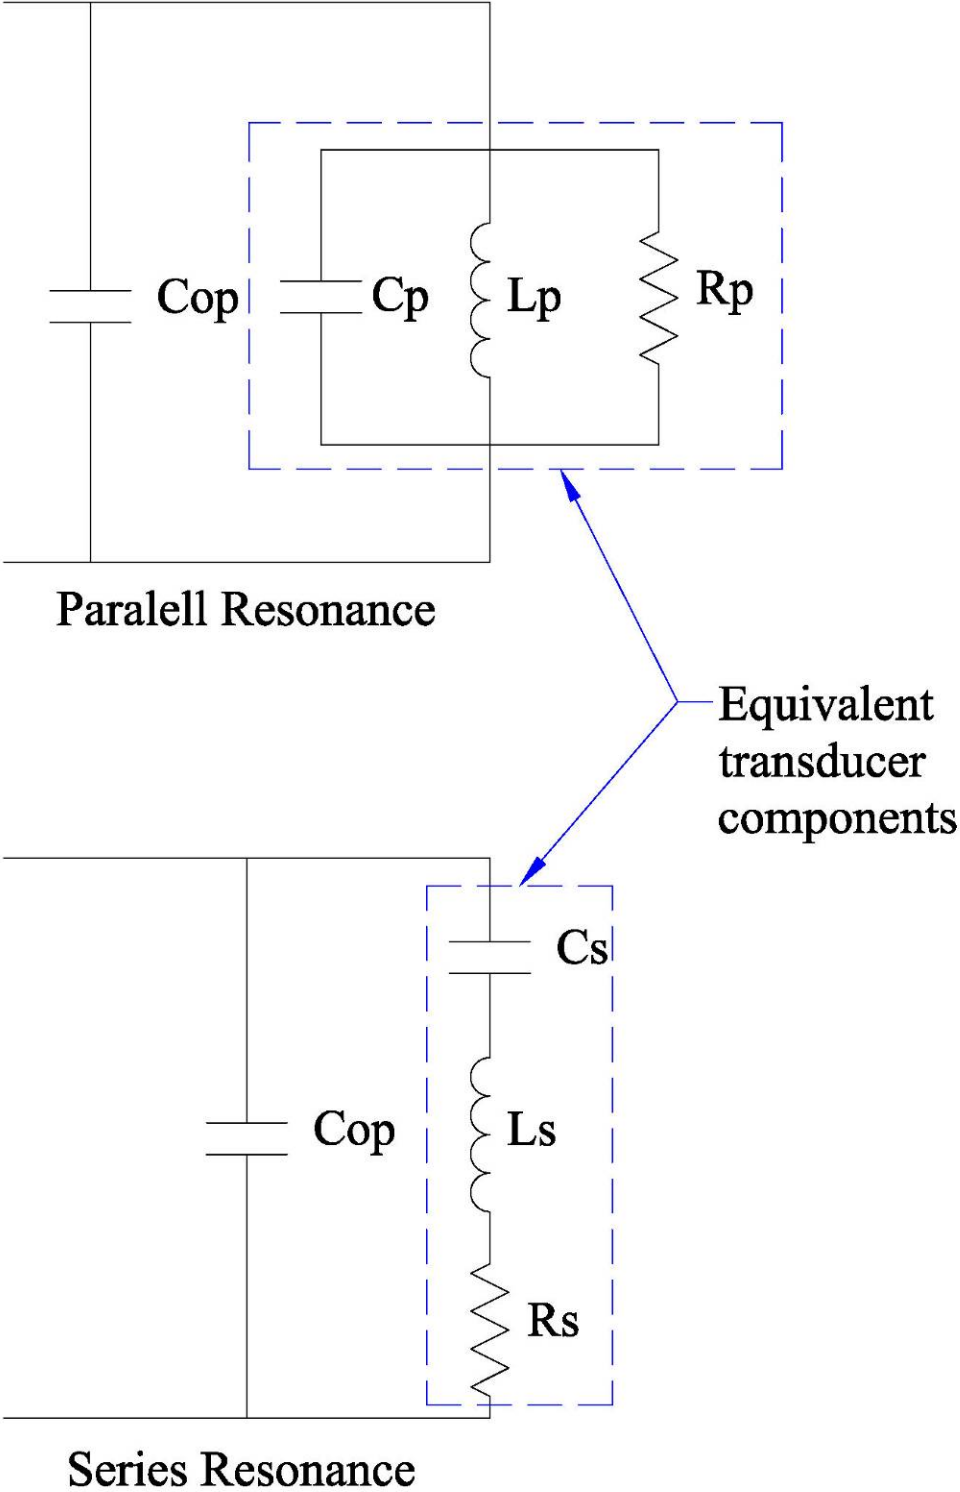
Figure 2.8 – Equivalent series and parallel resonance circuits

During series resonance, L_s and C_s effectively cancel out as current flows back and forth between these two components. This creates a short circuit condition, as R_s is the only portion left in the circuit to resist the flow of current. This leads to high current and low voltage or low impedance. Since the capacitor and inductor being discussed represent a mechanical system, they can also be described as follows. During series resonance, the energy is shifting back and forth between potential energy (mass) and kinetic energy (spring). At full transducer extension, whether the transducer is in tension or compression, the velocity is momentarily zero and all the energy is stored as potential energy. At the time of highest velocity, half way through a full cycle, the kinetic energy is maximized and the potential energy is zero. During series resonance, Cos has no effect on the system performance, as the impedance across it is very high and very little current flows through it [15].

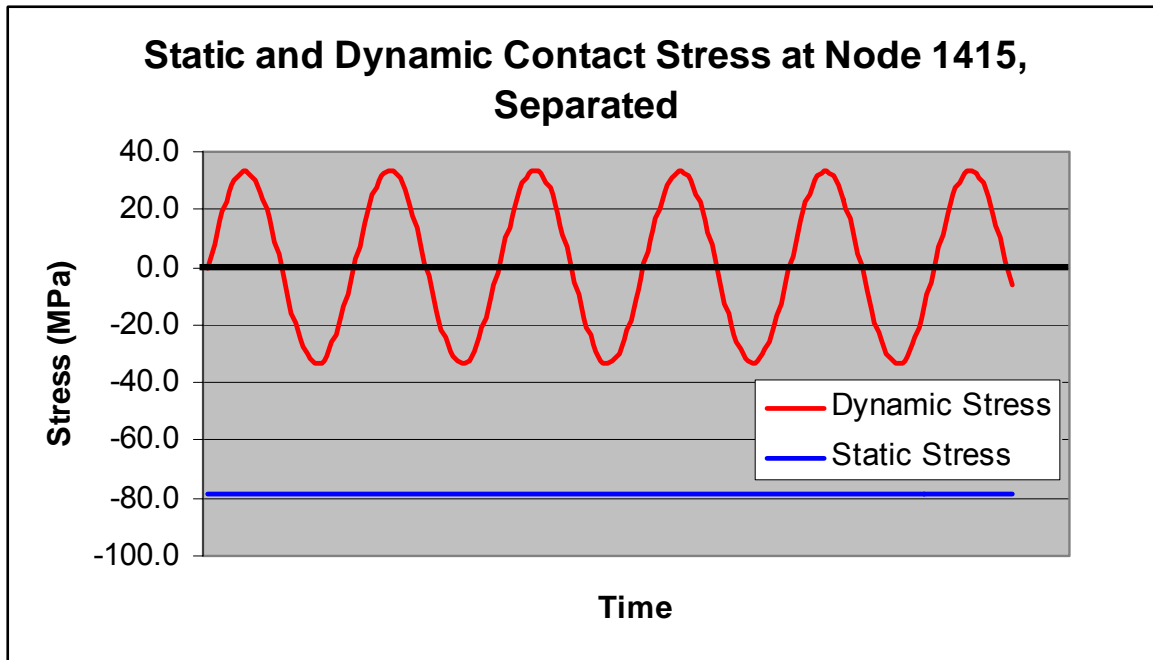
Figure 3.18 – Graphs illustrating summing of static and dynamic stresses to calculate total stress
– (a) Static and dynamic loads separated, (b) Static and dynamic loads combined

These failure points and corresponding safety factors can be calculated from the results of the static and harmonic analyses. Even though both dynamic and static stresses were calculated separately, they can be summed to produce a good approximation of the total stress during actual vibration, which can be visualized in figure 3.18. Using the calculated nodal stress values in the y-direction from both the static analysis at 44 kN and the harmonic analyses at 30,700 hertz, the stress at the ceramic interfaces can be calculated. These results determine how much the stress would have to increase in order to reach an uncompressed state at one point or across an entire surface. Because of the linear relationship between the ceramic stress and strain, this summation provides a safety factor which can be directly correlated to an amplitude limit not to be exceeded before failure occurs. For example, a safety factor of 200% indicates the amplitude or strain would have to double, which would in turn double the stress. The raw nodal calculation data can be found in appendix C. The graphs in figure 3.19 show the y-direction contact stresses at each interface along with the safety factor in percent and dotted lines indicating the localized failure point and the shifting failure point. The crystals are labeled as #1 for the disk closest to the top pre-tension nut and then in descending order, where disk #4 is the disk against the titanium body as shown in figure 3.2.
