THE MECHANICS OF ABRASION ON CONCRETE CROSSTIE RAIL SEATS

THESIS

Submitted in partial fulfillment of the requirements
for the degree of Master of Science in Civil Engineering
in the Graduate College of the
University of Illinois at Urbana-Champaign, 2013

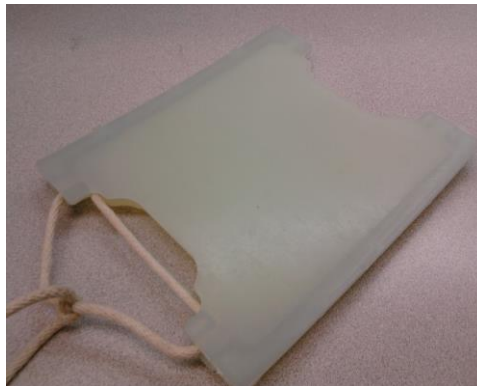
Figure 3.2 Bottom of two-part pad assembly (flat)

Three different rail pads were tested with four common conditions where contaminants from the environment infiltrate the rail seat. The first pad was a 2-part polyurethane pad assembly with a flat bottom (Figure 3.2). In contrast, the second and third polyurethane pads had studded (Figure 3.3) and dimpled (Figure 3.4) geometry, respectively. The conditions simulated were (i) dry contact interface (control), (ii) sand added, (iii) water added, and (iv) water and sand added. Sand and water were added manually to the contact interface in this experiment.

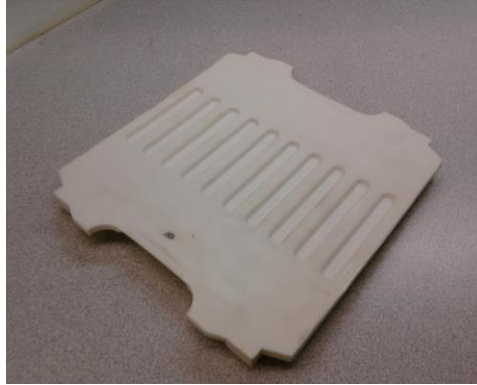
Figure 3.3 Bottom of studded pad

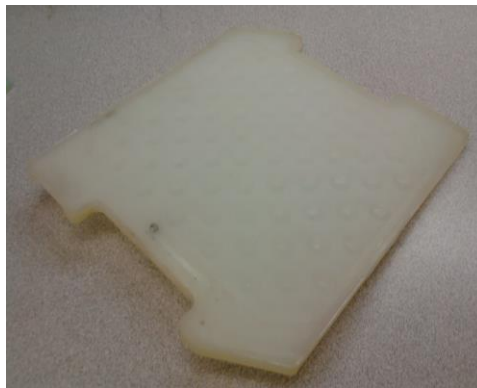
Figure 3.4 Bottom of dimpled pad

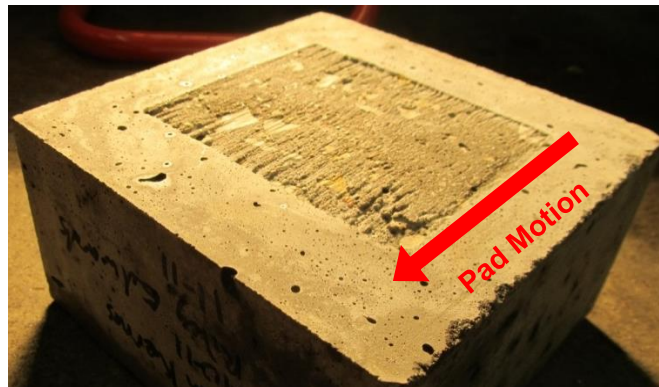
Figure 4.3 Increased abrasion along pad edges of concrete specimen after deterioration test

Similar to the shakedown tests, the pad materials in the ten deterioration tests exhibited severe deterioration at the primary load bearing contact points where increased temperatures led to softening and plastic flow of the material. The recorded temperature of the concrete was as high as 181° F when it was measured a few seconds after the test ended. Therefore, the pad temperatures were assumed to be above 200° F during the tests. The increased temperature and

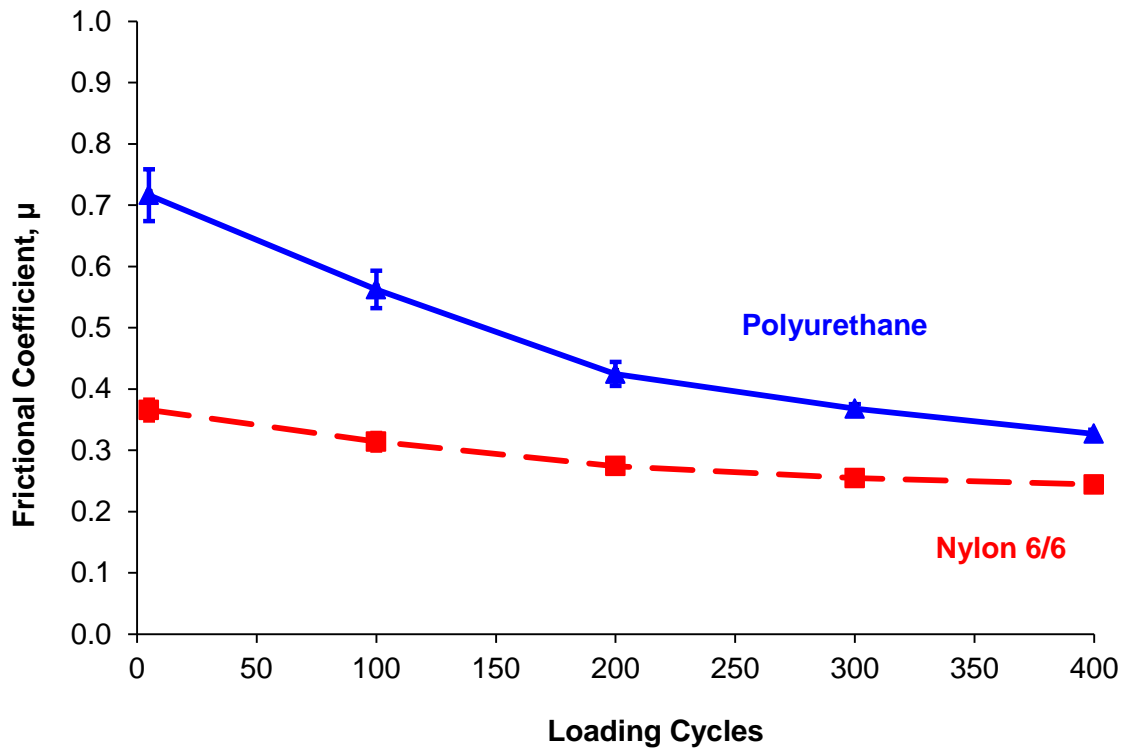
Figure 5.2 Mean coefficients of friction of polyurethane and nylon 6/6 pad materials during heat/deformation tests (mean \pm 2SE)

The mean COF values were plotted at loading cycles 5, 100, 200, 300, and 400 for all tests with nylon 6/6 pads and polyurethane pads (Figure 5.2). Error bars on these graphs (throughout Chapter 5) show two standard errors. The most noticeable trend observed during the heat/deformation tests is that the COF appears to decrease as loading cycles increase. For both pad materials tested, a noticeable decline in the COF was observed from the beginning of each test (loading cycle 5) to the end of each test (load cycle 400). The COF values for each concrete specimen and pad pair for all friction tests are plotted in Appendix B: Detailed Results of Friction Experiment.

The decline in COF as a function of time during a simulated train pass is most likely due to the buildup of thermal stresses at the contact interface. Increases in the temperature of the pad at the local contact points were observed in all of the friction tests. T_f values as high as 351° Fahrenheit (F) were recorded on the surface of nylon 6/6 pads and 277° F on the surface of polyurethane pads. The temperature build-up appeared to be localized to the primary load-bearing contact points on the pad. On portions of the pad that did not appear to be in direct contact with the concrete, temperatures were measured within 5° of T_i . At these regions of increased temperatures, the material appeared to soften, leading to plastic flow and severe deformation. Evidence of the plastic flow and tearing are presented in Appendix C: Examples of Pad Deterioration from Friction Experiment.

The second conclusion from the mean COF values in Figure 5.2 is that the nylon 6/6 pads appear to have lower COF values than polyurethane pads. The COF values for polyurethane pads were consistently higher than the values for nylon 6/6 pads, including different pads tested on the same concrete specimen. During tests with polyurethane pads, the pad appeared to be absorbing a portion of the shear strain internally (i.e. within its own geometry and thickness), such that gross slip of the pad relative to the concrete was smaller than that of the nylon 6/6 pads.

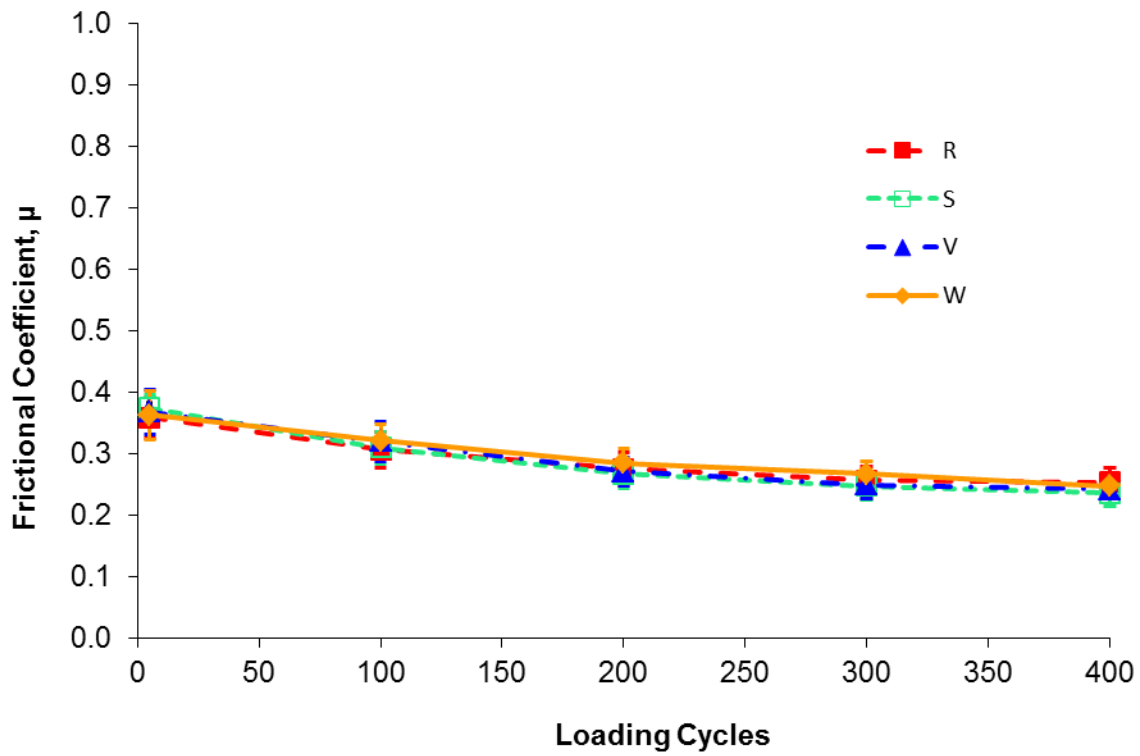
Figure 5.3 Mean coefficients of friction by test order of nylon 6/6 pad materials

Third, although there was visible evidence that plastic deformation of the pad and smoothing of the concrete surface occurred during each simulated train pass, there was no conclusive result regarding the effect of subsequent test runs on the frictional characteristics. The COF values were separated by test order (R, S, V, and W) and the mean values were plotted separately for each pad material during the heat/deformation tests (Figures 5.3 and 5.4). The mean COF values remained nearly constant for nylon 6/6 pads with no apparent effect of the previous tests as can be seen in the tight band of curves in Figure 5.3. Alternatively, the first 100 cycles of the polyurethane pads resulted in higher COF values than any other cycles (Figure 5.4).

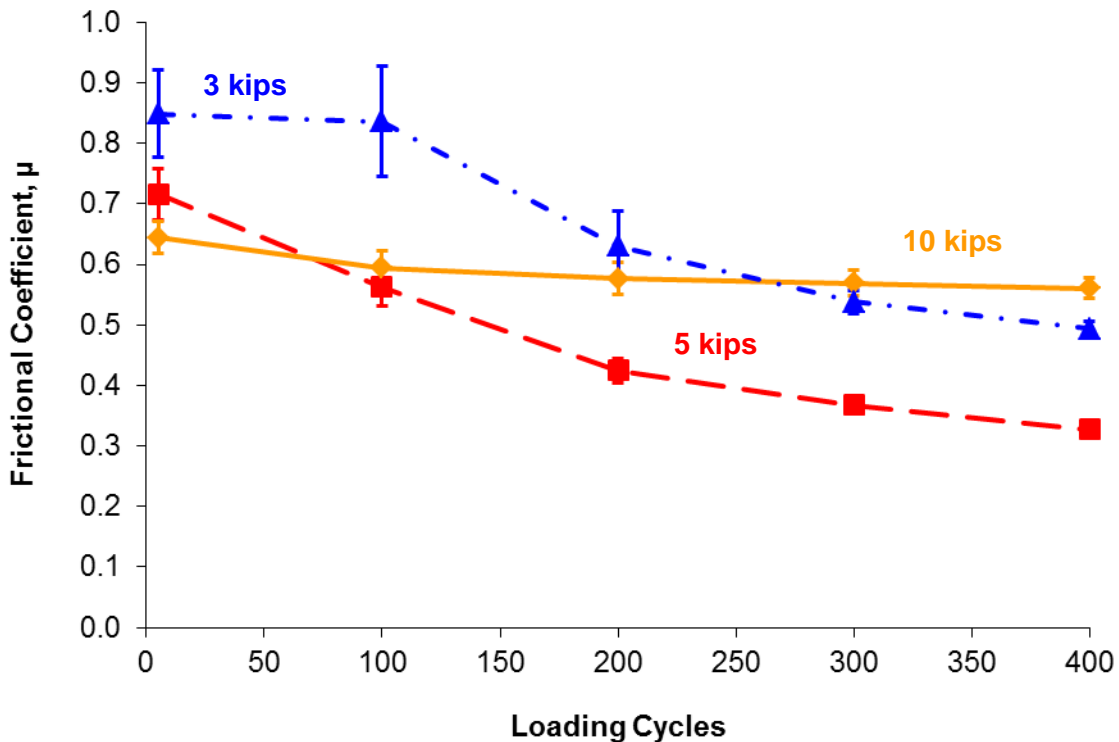
Figure 5.6 Mean COF values of polyurethane pads under 3-kip, 5-kip, and 10-kip normal loads

By contrast, the COF data for the polyurethane pads do not show a strong correlation between normal force and COF for tests with loads of 3 kips and 10 kips (Figure 5.6). The COF values at loading cycles 5 and 100 were lower at 10-kip loads than at 3-kip loads, but the COF values were higher at 10-kip loads than 3-kip and 5-kip by the end of the tests. However, the COF values for tests with a 5-kip normal force were consistently lower than the COF values for polyurethane pads loaded to 3 kips.

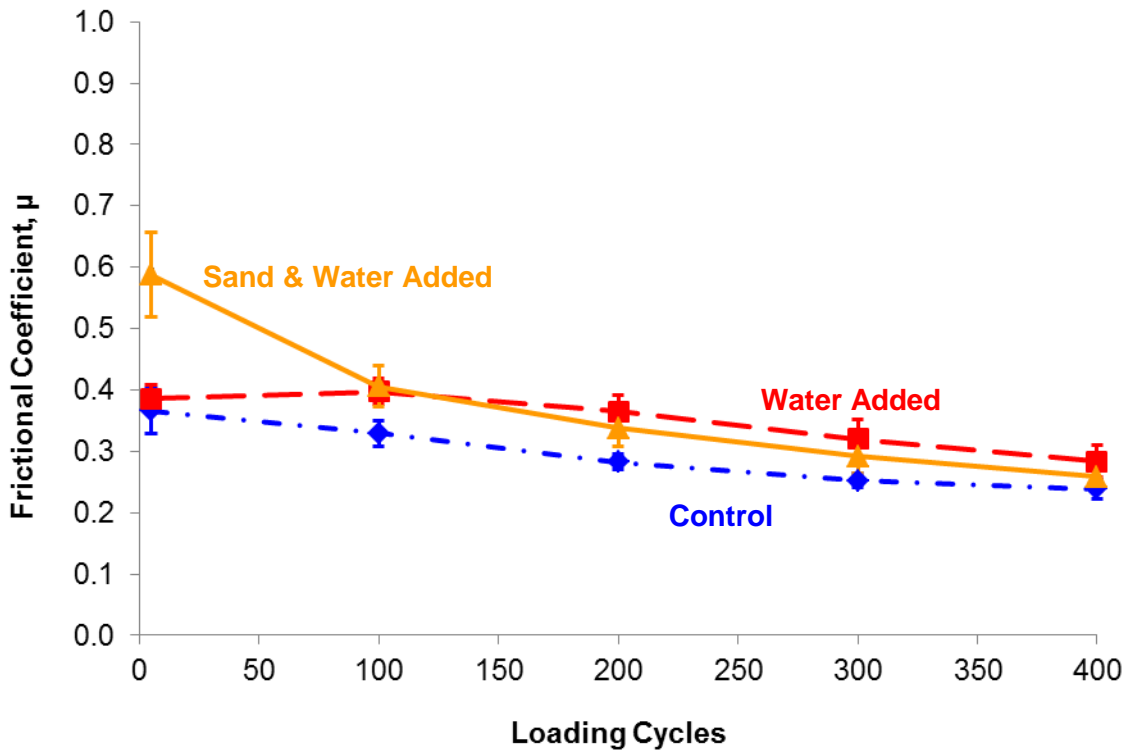
Figure 5.7 Mean COF values of nylon 6/6 pads with 3 rail seat contaminant conditions

From the mean COF values of all 16 trials on nylon 6/6 pads for each rail seat contaminant condition, the COF values were slightly higher with sand and water added relative to the control (Figure 5.7). As the loading cycles progress, the COF values for each environmental condition trended toward the same value, near 0.3.

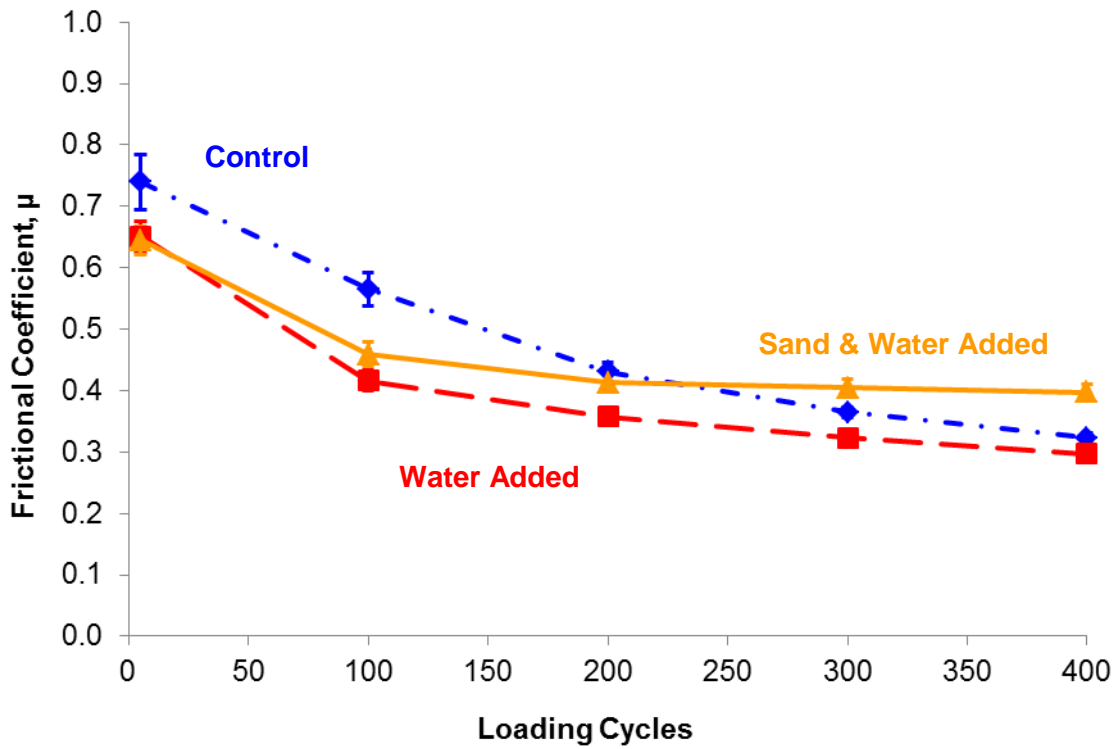
Figure 5.8 Mean COF values of polyurethane pads with 3 environmental conditions

In contrast, the COF was slightly lower than the dry condition when water and the combination of sand and water were added to tests with polyurethane pads during the first 200 loading cycles (Figure 5.8).

After loading cycle 200, the polyurethane pads with water added continued to have lower COF values than the control condition. However, polyurethane pads with sand and water appeared to have an average COF that is slightly greater than the control after loading cycle 300.

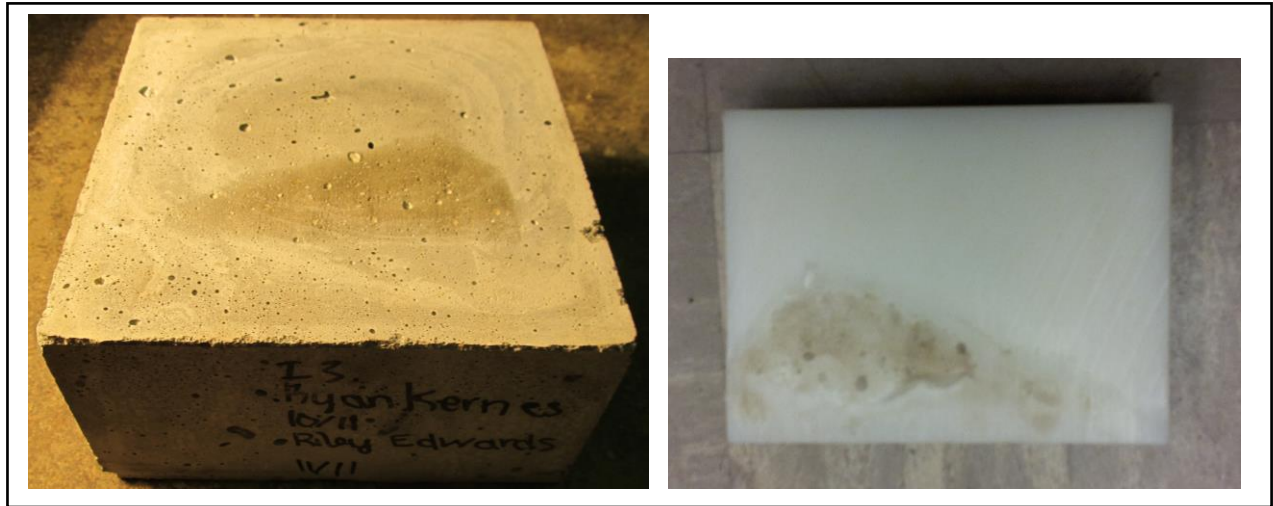
Figure C.1 Heat/Deformation Test 1.1 Nylon 6/6 Pad

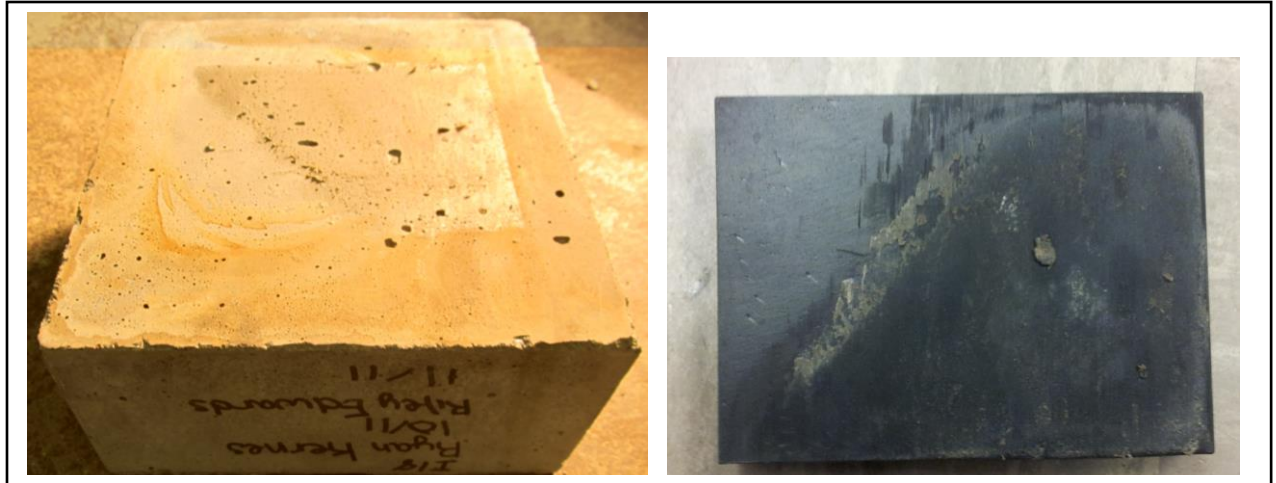
Figure C.4 Heat/Deformation Test 1.7 Polyurethane Pad
