# Development of a Long-term, Multimetric Structural Health Monitoring System for a Historic Steel Truss Swing Bridge

**Ryan K. Giles**  
and  
**Billie F. Spencer, Jr.**

Department of Civil and Environmental Engineering  
University of Illinois at Urbana-Champaign

UILU-ENG-2015-1805

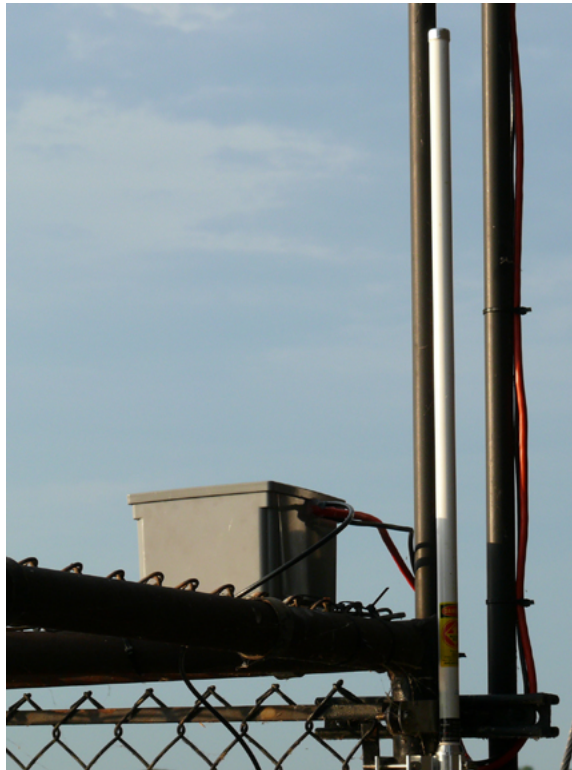
Figure 7.3: The gateway node installed outside the operator's house on the Government Bridge.
