Performance Evaluation of Stabilized Support Layers for Concrete Pavements

Research Report No. FHWA-ICT-22-003

ICT PROJECT R27-193-6

February 2022

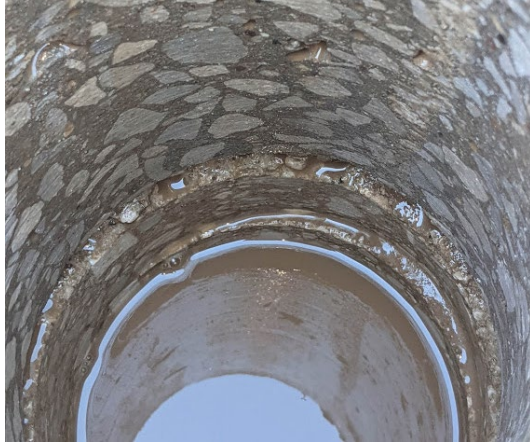
a) US 67 SB 26+600 outer wheel path coring hole

Figure 21. Photos. US 67 SB 26+600 outer wheel path core with erosion.

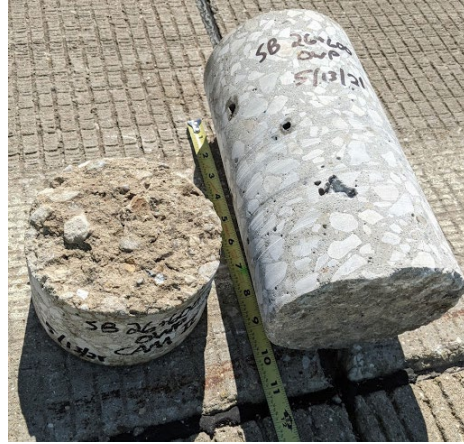
b) US 67 SB 26+600 outer wheel path core (CAM II potentially eroded surface on left)

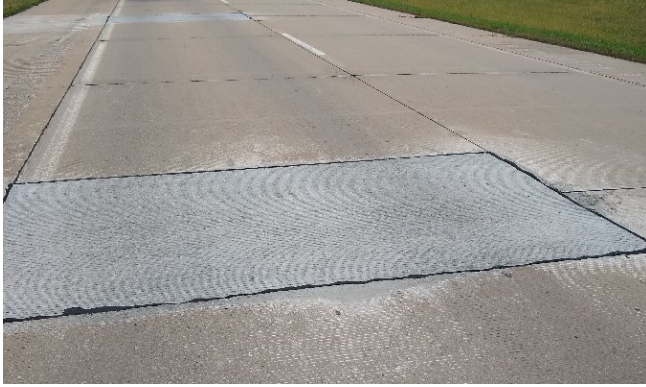
Stationing	Detailed Distress Survey Notes: US 67 (28+650 to 21+537)¹
Section SB-1 (28+655)	
28+660	New full-depth repair (FDR) performing well (6 ft length 12 ft wide; DL only); should have extended into PL due to corner failures
28+655	Temperature holes drilled and recorded at 12:15 pm (1.5 in., 5 in., and 9 in.)
28+655 to 28+632	Corner distress throughout section similar to NB (DL approach and leave along the DL/PL longitudinal joint); severe failures include HMA patches or spray injection patching
28+646	Reflector in PL has HMA patch over reflector
28+615	Old FDR joints are excessively wide and spalling (7.5 ft length spanning DL and PL); some HMA patching or spray injection patching has been done along the joints
28+632	End of Section SB-1 intensive FWD testing (No MIRA testing performed)
Section SB-2 (27+610)	
27+610 to 27+587	Corner distress throughout section (DL and PL approach and leave) with majority in PL; severe failures include HMA patches in corners and over damaged raised pavement markers

a) New FDR performing well in DL; corner distress in PL along leave joint adjacent to repair (28+660 SB)

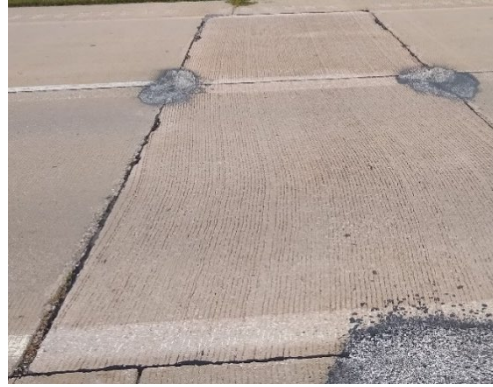
b) Old FDR with excessively wide joints and HMA or spray injection patching (28+615 SB)

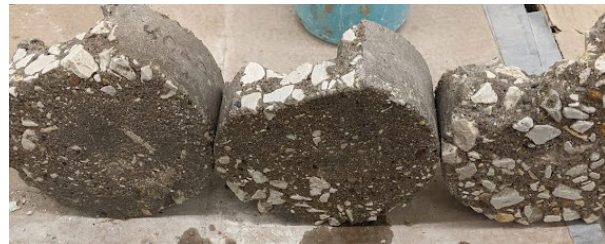
The initial testing performed on CAM II Mix #1 did not include a rubber pad beneath the specimens, causing deterioration to occur between the interface of the bottom of the specimen and the metal frame. This also influenced failures of the specimen and caused violent movements of the testing device. These violent movements influenced the decision to reduce the maximum loading to 10,000 cycles which allows testing to be completed within one day and an operator present throughout testing. To eliminate this undesirable affect, a rubber pad was placed beneath all future specimens within the HWTD frame. No weight loss measurements were recorded for CAM II Lab Mix #1. Testing of this mixture was repeated to examine the effects from the rubber pad and weight loss.

d) Bottom of specimens (deterioration from contact with metal frame)

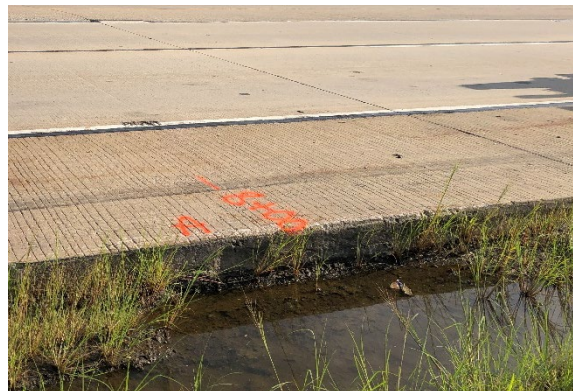
All cores were fully bonded between the PCC and HMA stabilized support layer. The only location that potentially had some erosion occurring was EB 8+00 in the outer wheel path. This location has pooled water along the outside shoulder edge and is most likely leading to stripping of the bottom of the HMA (See **Figure 191**). This pooling of water was present on both dates of testing, FWD (8/13/2020) and coring (11/20/2020).

Figure 192. Photo. US 30 (62277) EB 8+00 core location #3 with pooling of water along free edge.

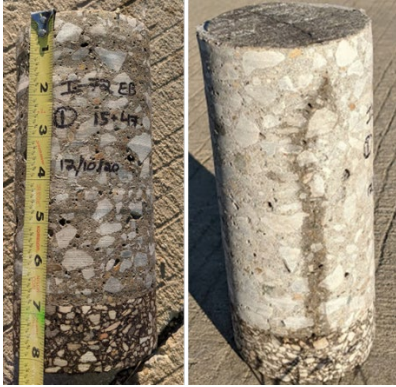
All cores showed a bonded condition between the bottom of the PCC overlay and the HMA interlayer. There was no bond present between the bottom of the HMA interlayer and existing CRCP. The cores over the longitudinal cracks in the wheel path were held very tight due to the engaged fibers. In order for the crack to be visible, moisture needed to be present (see **Figure 196a** and **b**). Unfortunately, there was no visible permanent deformation in the wheel path versus non-wheel path. An interesting phenomenon occurring at the core locations over the longitudinal crack in the wheel path near the

Outer wheel path (approach joint): Over longitudinal crack

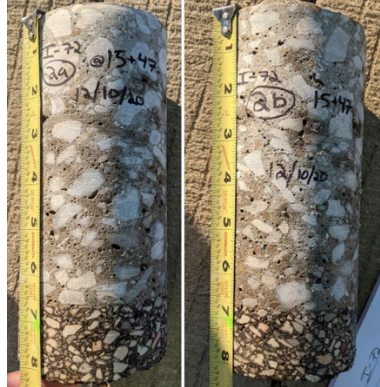
Outer wheel path (approach joint): NOT over longitudinal crack

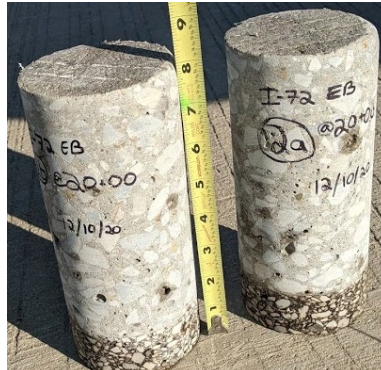
Outer wheel path (approach joint): NOT over longitudinal crack

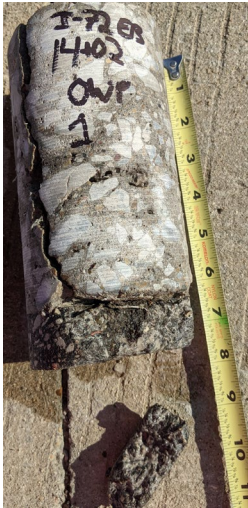
deterioration of the propagated PCC joint crack through the HMA layer. The cores remained together in the FRC overlay, as the fibers were bridging the transverse joint and working properly. Some of the cores exhibited stripping, as seen in **Figure 197**.

A. 14+02 EB OWP longitudinal crack on leave; stripping on leave only

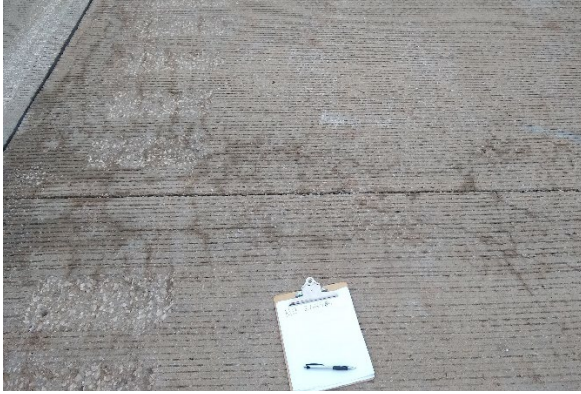
Stationing	Detailed distress notes: US 67 NB (23+700 to 28+650)
Section NB-1 (24+599)	
24+600	Temperature holes drilled and recorded at 9:00 am and 2:45 pm (1.5 in., 5 in., and 9 in.)
24+594 to 24+622	Material related cracking in the shoulder (ASR); Corner failures (micro-cracking) in DL on approach and leave slab along longitudinal joint between PL and DL (Raised pavement markers in PL near corners potentially relieve stress and not causing corner cracking to occur in PL); Concrete pop-outs also occurring throughout section
24+622	End of Section NB-1 intensive FWD testing and MIRA
Section NB-2 (25+990)	
25+995	Corner failures (micro-cracking) in DL on approach and leave slab along longitudinal joint between PL and DL (Raised pavement markers in PL near corners potentially relieve stress and not causing corner cracking to occur in PL)
26+016	Durability cracking in the DL near approach joint; construction flaws in section with pop-outs

a) Durability cracking in the Outer Shoulder (24+594 NB)

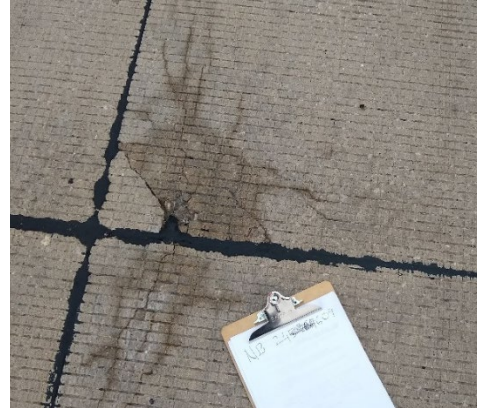
b) Corner distress or durability cracking in DL (24+609 NB)

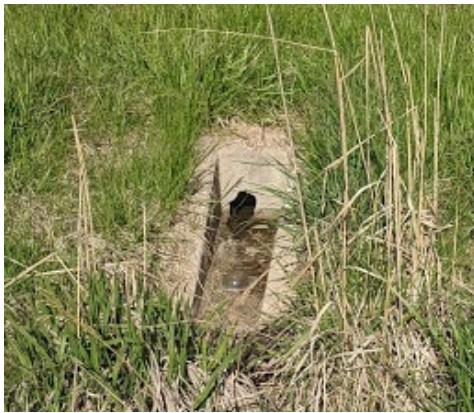
c) Clear drain outlet (26+000 NB)

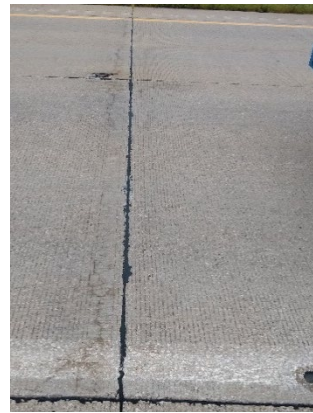
d) Durability cracking in the DL and PL with pop-out (26+016 NB)

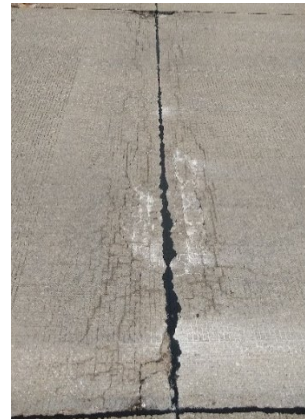
28+587	Good bond recording with MIRA; Coring location NB-4A
28+645	Concrete pop-outs occurring
28+610	End of Section NB-4 intensive FWD testing (No MIRA)
Section NB-5 (23+799)	
23+799 to 23+822	Concrete popouts occurring; Full-depth repairs of transverse joints near intensive testing section (6 ft lengths with full-lane widths); Damage mostly occurring in DL; ASR in majority of DL panels near transverse joints
23+814	Corner failures with HMA patching; ASR in DL in approach and leave slab
23+839	Severe ASR causing a depression near the joint, approach and leave slab feel unsupported near the joint
23+822	End of Section NB-5 intensive FWD testing (No MIRA)

f) Severe ASR (23+839)

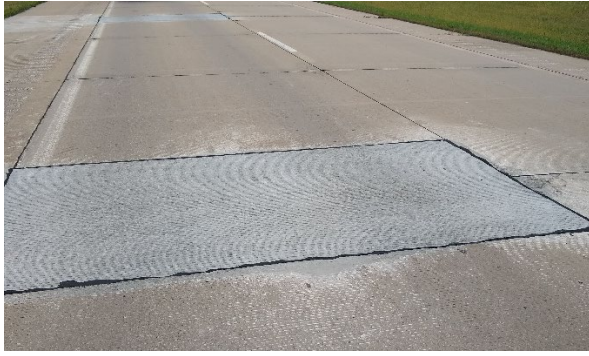
Stationing	Detailed distress notes: US 67 (28+650 to 21+537)¹
Section SB-1 (28+655)	
28+660	New full-depth repair (FDR) performing well (6 ft length 12 ft wide; DL only); should have extended into PL due to corner failures
28+655	Temperature holes drilled and recorded at 12:15 pm (1.5 in., 5 in., and 9 in.)
28+655 to 28+632	Corner failures throughout section similar to NB (DL approach and leave along the DL/PL longitudinal joint); severe failures include AC patches
28+646	Reflector in PL has HMA patch over reflector
28+615	Old FDR joints are excessively wide and spalling (7.5 ft length spanning DL and PL); some HMA patching has been done along the joints
28+632	End of Section SB-1 intensive FWD testing (No MIRA testing performed)
Section SB-2 (27+610)	
27+610 to 27+587	Corner failures throughout section (DL and PL approach and leave) with majority in PL; severe failures include HMA patches in corners and over damaged raised pavement markers

a) New FDR performing well in DL; corner failure in PL (28+660 SB)

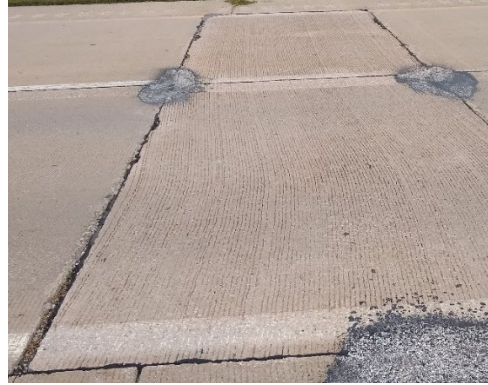
b) Old FDR with excessively wide joints and HMA or spray injection patches (28+615 SB)

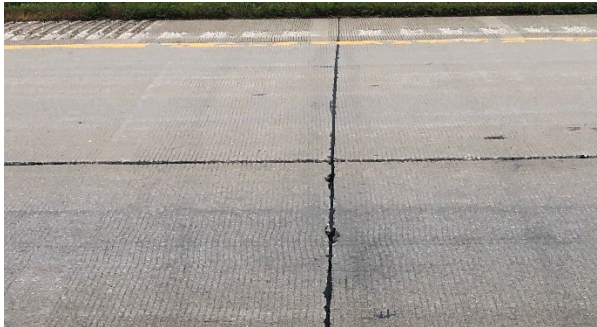
c) Longitudinal joint faulting (Section WB-2)

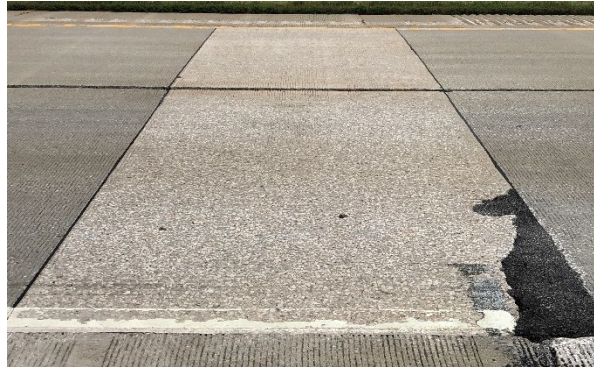
h) FDR with HMA patch and Longitudinal faulting (2+030 WB)

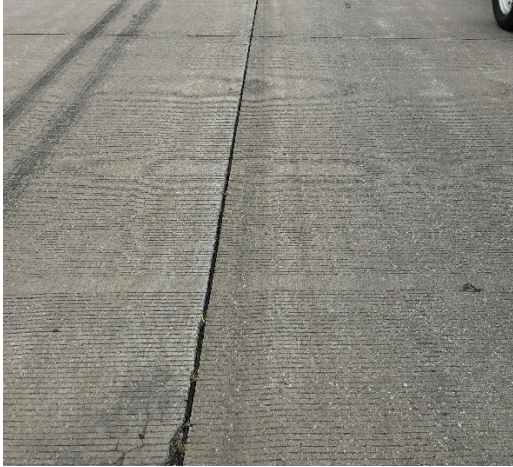
Stationing	Detailed distress notes: I-72 EB (1+200 to 2+850)
Section EB-1 (1+315)	
1+315 to 1+365	Longitudinal joint between PL/DL excessively wide (~1 in.) and faulting with PL>DL; Longitudinal joint is sealed but due to width, sealant may not be able to prevent infiltration; Rebound Index in DL and Shoulder between 6-8 ksi (45-55 MPa)
1+315	Temperature holes drilled and recorded at 12:15 pm (1.5 in., 5 in., and 9 in.); Corner failures in PL leave slab along PL/DL longitudinal joint
1+330	Corner failure with pop-out (~5 in. radius) in DL approach along PL/DL longitudinal joint; Reflector damaged and replaced, new reflector has cracking
1+365	End of Section EB-1 intensive FWD testing (No MIRA testing performed)
Section EB-2 (1+705)	
1+705 to 1+755	Minor corner failures in DL approach along DL/Shoulder longitudinal joint, occurring in multiple panels
1+715	Corner failure in PL approach slab along PL/DL longitudinal joint; Reflector damage; Wide longitudinal joint between PL/DL

a) Wide longitudinal joint between PL/DL (Section EB-1)

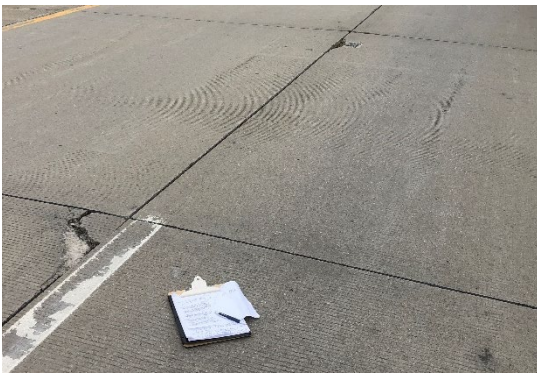
c) Corner failure in PL approach and reflector damage (1+715 EB)

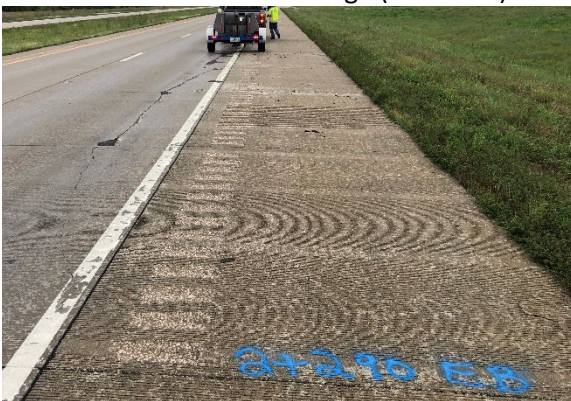
e) Edge failure due to lack of support (2+290 EB)

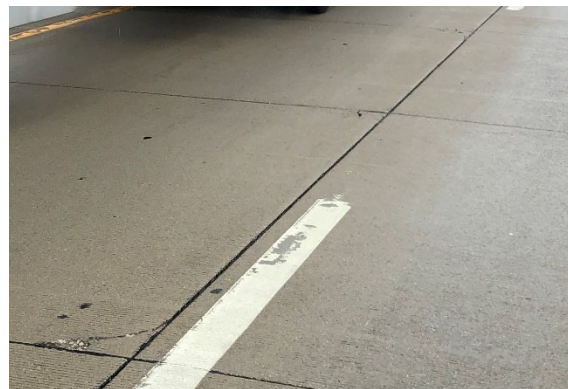
f) Corner distress in PL (Section EB-4)

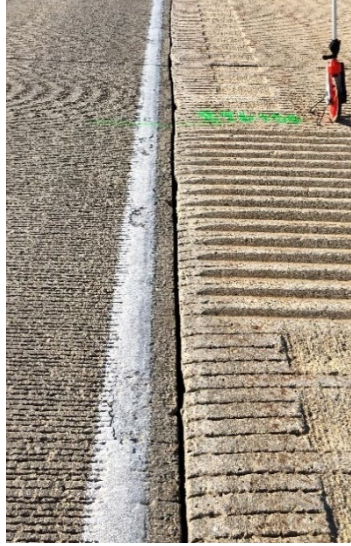
a) Lane-shoulder long. jt. (896+00)

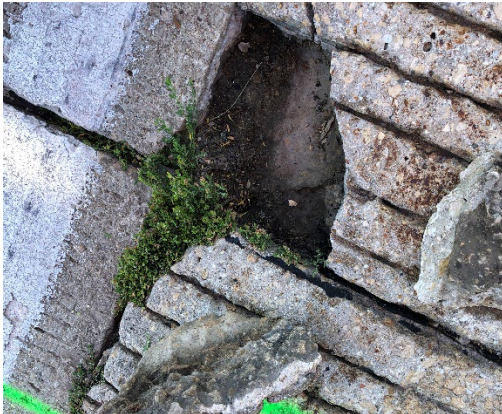
Stationing	Detailed distress notes: Section E (895+00 to 904+00)
Section E-1 (895+00)	
895+00 to 904+00	Trans. jts. all are ~0.75-in. wide; joint spalling common along section; appears all trans. jts. sealed with hot poured jt. sealant and HMA patches along large spalled jts.; common corner cracking along shoulder leave jt. L/S long. jt. (~8 in. radius)
894+00	Long. cracking across two adjacent panels in DL (~1.5 mm width)
895+60	Corner break leave slab along L/S long. jt. (~9-in. radius)
896+00	L/S long. jt. inconsistent height between lanes and wide with spalling; unclear if long. faulting is occurring or if construction elevation differences between L/S
896+20	Trans. jt. spalling with HMA patch, vegetation growing out of jt.
895+75	End of Section E-1 intensive FWD and MIRA testing
Section E-2 (898+00)	
897+60	Trans. crack DL; jt. sealant damage and jt. full of incompressible fines
898+00	Corner crack along shoulder (L/S long. jt.) – leave slab, fines slurry appears to have pumped under crack (~2 in. depth from surface of concrete)-see photo

c) Corner crack and popout with fines slurry along lane-shoulder long. jt – leave slab in shoulder (898+00)

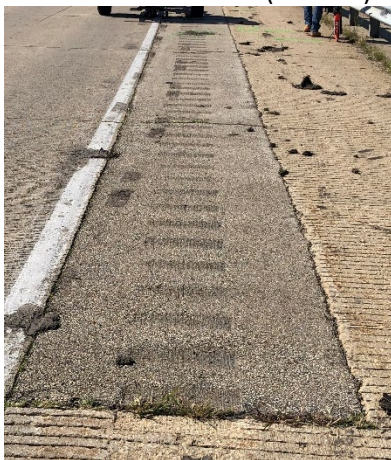
e) HMA partial depth repair along shoulder (901+65 to 904+00)

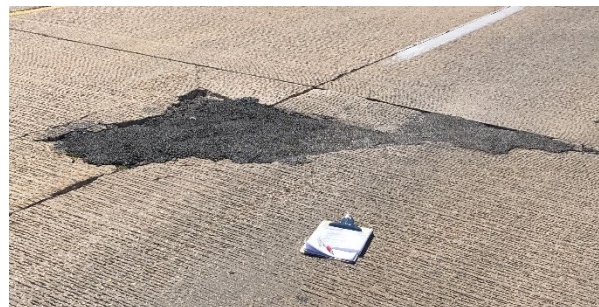
898+15	HMA patch of corner spall along L/S long. jt. – both approach and leave slab
898+75	End of Section E-2 intensive FWD testing (No MIRA testing performed)
Section E-3 (900+00)	
899+85	Corner crack in PL along leave jt. (~14 in. radius)
901+00	DL/PL long. jt. damage; corner cracking; HMA patch present but distress deteriorating
900+75	End of Section E-3 intensive FWD and MIRA testing
Section E-4 (902+00)	
901+65 to 904+00	HMA partial depth repair along L/S long. jt., repair is 4-ft wide and 2-in thick
902+00	Corner crack along L/S long. jt. (approach and leave) – DL and Shoulder (~8-in. radius)
902+30	Long. cracking in shoulder (mid-panel); HMA patch present but crack length extends on both ends of patch to adjacent trans. jts.
903+00	Corner failure in approach slab of DL and PL with HMA partial depth repair. See photo
902+75	End of Section E-4 intensive FWD and MIRA testing

f) Corner break spanning DL and PL with HMA partial depth repair (903+00)

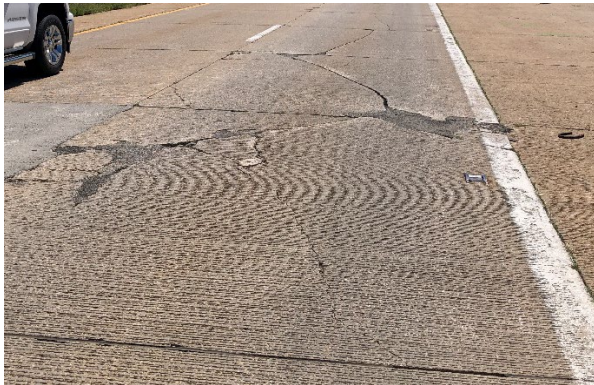
c) Shattered slabs in DL with some HMA patching (996+70)

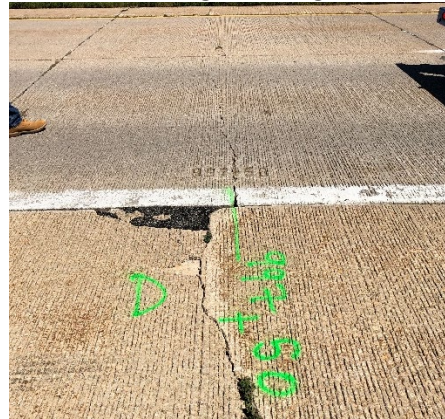
d) Mid-panel trans. cracking (997+50)

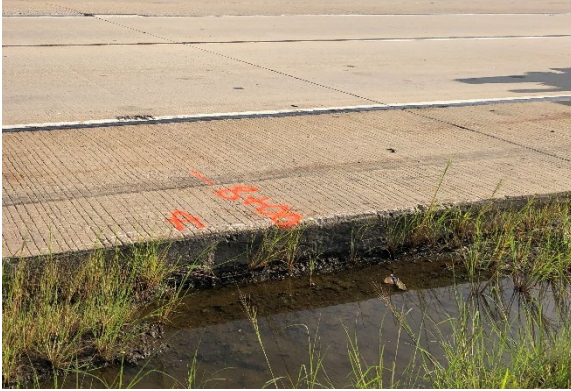
a) Free edge has pooling of water (8+00 EB)

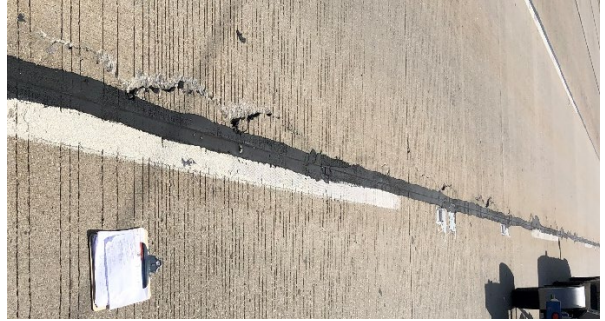
b) Severe long. cracking along long. jt between DL & PL (70+75 EB)

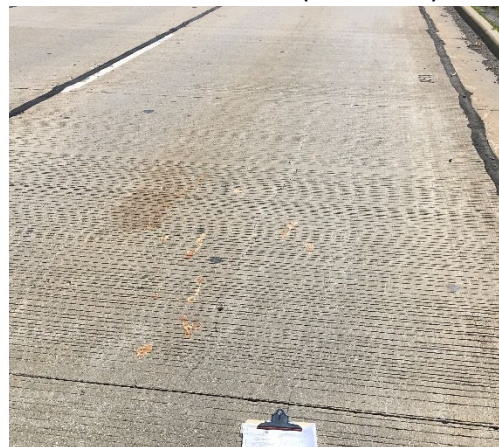
d) Long. cracking mid-slab spanning two panels (72+00 EB)

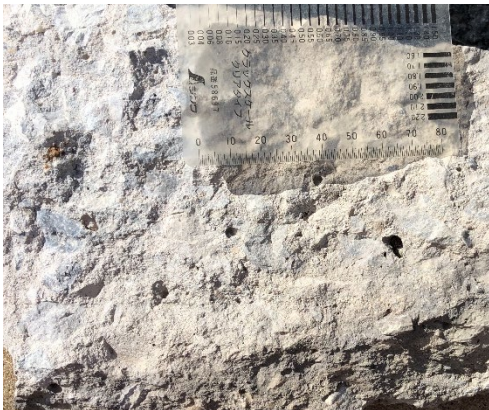
Eastbound Sections 2, 3, and 4 appear to have poor consolidation in the concrete. MIRA images show potential delamination/ poor consolidation between the top 50-100 mm (2-4 in.). Removed concrete where full-depth repairs performed show large air voids in the concrete confirming MIRA scanning. Potentially able to see the reflection of the bottom of the HMA subbase layer within Section 3A.

e) Concrete shows entrapped air

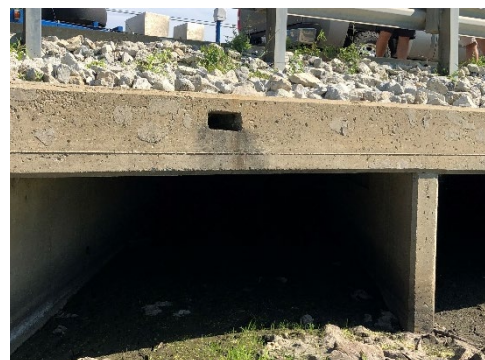
72+00 EB	Long. and transverse cracking; shallow culvert below (cause of cracking)
Section 4 (79+75 EB)	
80+20 EB	No noticeable distress in this section; end of intensive testing (Section 4)
Section 5 (94+90 EB)	
95+65 EB	No noticeable distress in this section; end of intensive testing (Section 5)

f) Culvert causing cracking in PCC (72+00 EB)

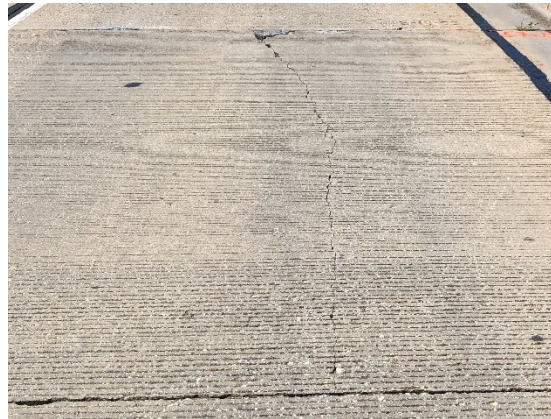
d) Long. cracking spanning two panels
(57+25 WB)

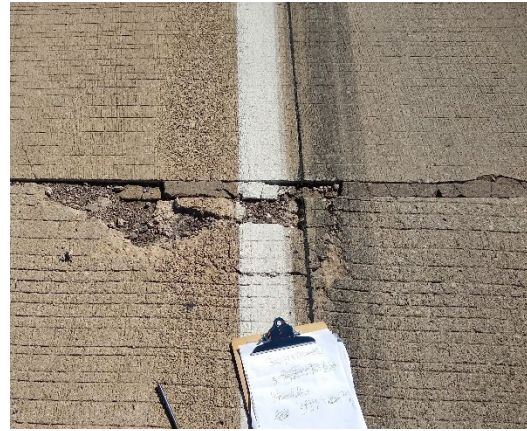
Section WB-4 (3299+30)	
3301+00	Transverse crack over drain; avoided testing over drain
3299+99	Corner distress, joint spalling, and faulting
3299+84	Joint spalling
3299+68	Severe joint damage, very tight joint and potential location of blow-up to develop (late sawcutting – led to crack to develop along trans joint in shoulder)
3298+55	End of Section WB-4 intensive FWD testing and MIRA

b) Corner failure, joint spalling and faulting
in DL and Shoulder – Leave (3299+99
WB)

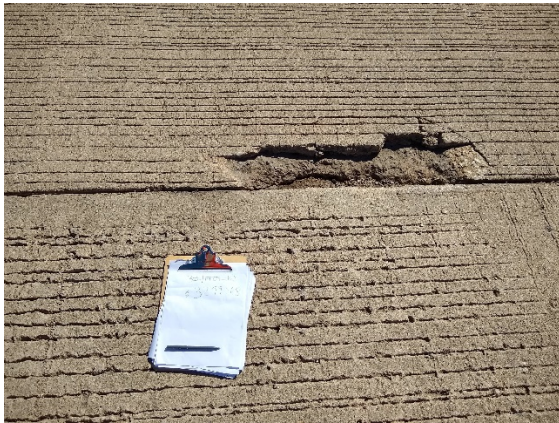
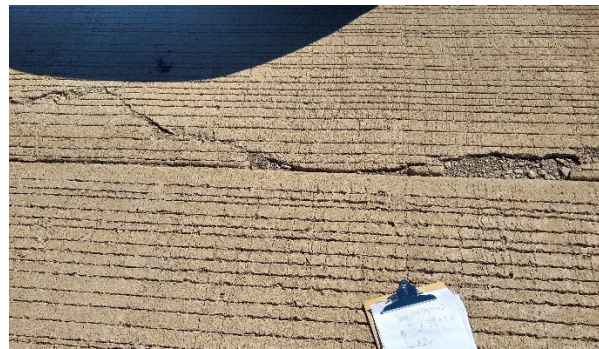
c) Severe joint damage in DL and Shoulder -
Approach (3299+68 WB)

d) Severe joint damage in DL and Shoulder -
Approach (3299+68 WB)

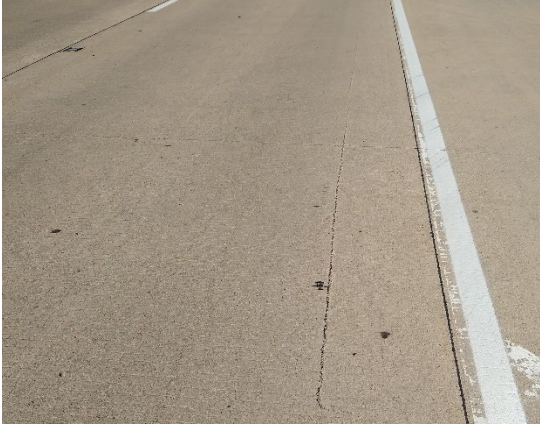
Stationing	Detailed distress notes: IL 64 (3284+00 to 3412+25)
Section EB-1 (3289+45)	
3289+45	Temperature holes drilled and recorded at 11:40 am (1.5 in., 5 in., and 9 in.)
3290+75	Longitudinal impression in OWP of DL from tining machine (see Figure 216a)
3290+20	End of Section EB-1 intensive FWD testing and MIRA
Section EB-2 (3325+56)	
3326+31 to 3327+66	Random joint spacing observed (15 ft, 15 ft, 14 ft, 13 ft, 17 ft, 15 ft, 16 ft, and 14.5 ft)
3325+56 to 3326+31	No visible distress observed
3326+31	End of Section EB-2 intensive FWD testing (No MIRA testing performed)
Section EB-3 (3378+76)	
3380+26	Longitudinal cracking in DL on Leave slab near transverse joint; cracking potentially directly over top of dowel bars.
3379+51	End of Section EB-3 intensive FWD testing and MIRA
Section EB-4 (3405+96)	
3405+96 to 3406+71	Diamond grinding performed in the DL; exposing voids in the concrete near the surface (extends longer than intensive Section EB-4)

a) Longitudinal impression in OWP of DL from tining machine (random locations in EB)

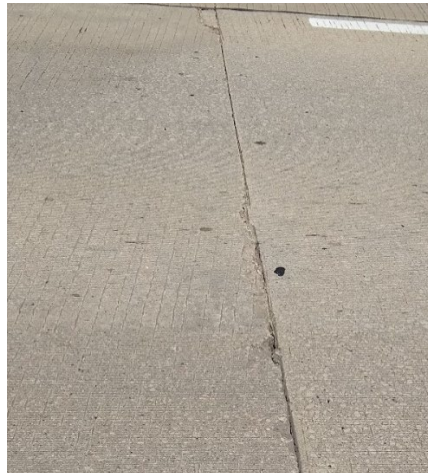
3405+51	Joint spalling with corner spalling along Approach joint in DL between PL and DL; joint does not have joint sealant (all others do within same section)
3405+96	Poor consolidation in concrete surface – large voids
3407+46	Surface cracking near transverse joint
3406+71 to 3407+31	Random joint spacing observed (15 ft, 11 ft, 16 ft, and 18 ft)
3406+71	End of Section EB-4 intensive FWD testing (No MIRA testing performed)

d) Joint spalling with corner spalling along Approach joint in DL (3405+51)

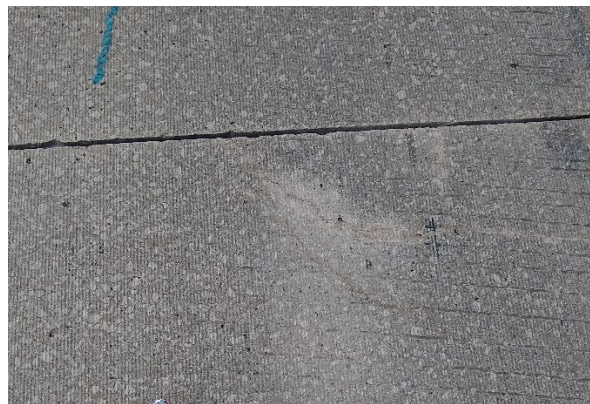
f) Surface cracking diamond ground (3407+46)

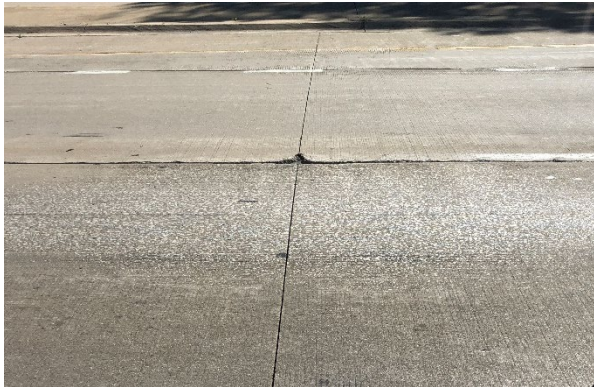
c) Corner distress and diamond grinding (234+47 SB)

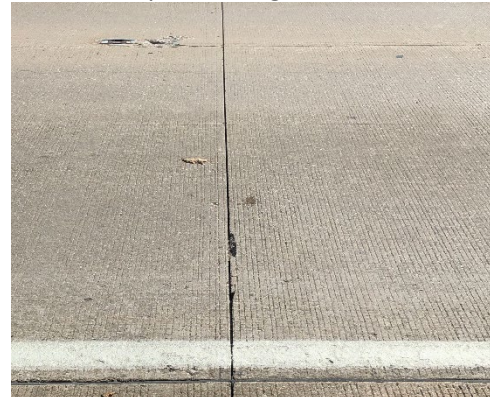
199+50	Minor transverse joint spalling in DL; no faulting
199+00	End of Section SB-3 intensive FWD and MIRA testing
Section SB-4 (150+45)	
150+45 to 149+00	Minor corner failures (< 1-in. radius) throughout Section SB-4 between PL and DL longitudinal joint
125+00	Longitudinal crack (mid-panel) in DL spanning three consecutive panels outside of intensive testing section near 125+00
149+00	End of Section SB-4 intensive FWD (No MIRA testing performed)
Section SB-5 (100+00)	
100+00 to 99+00	No observed distress in Section SB-5; Rebound Index in DL between 6-7.2 ksi
99+65	Maintenance hole in shoulder and possible drain under Panel C
99+00	End of Section SB-5 intensive FWD (No MIRA testing performed)

d) Transverse joint spalling (199+50 SB)

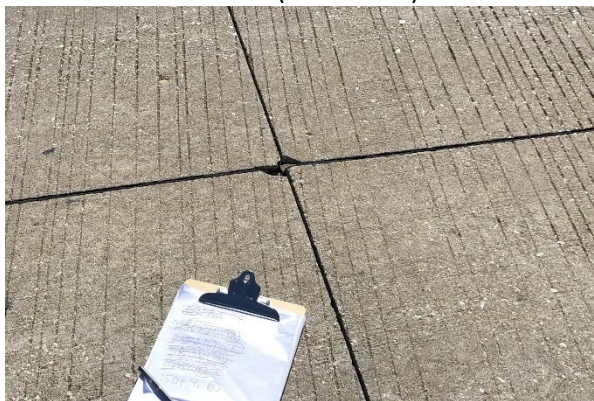
e) Minor corner spalling (150+45 to 149+00 SB)

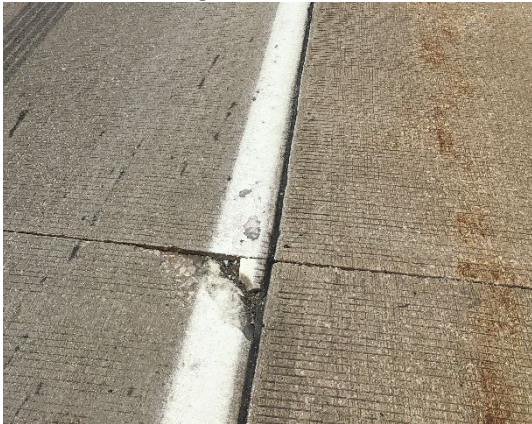
c) Corner distress along approach joint in DL (180+45 NB)

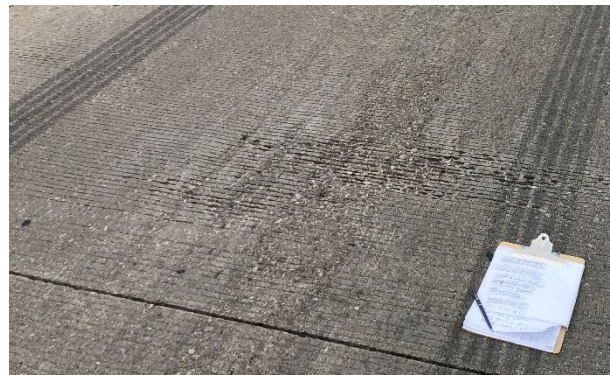
d) Ravelling on concrete surface in DL (180+90 NB)

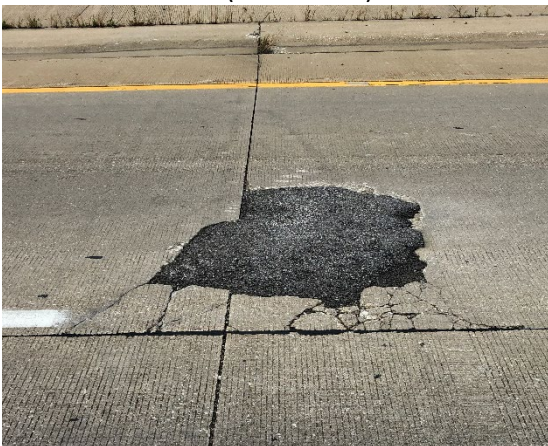
e) Corner break with HMA patch in PL on Approach and Leave (181+55 NB)

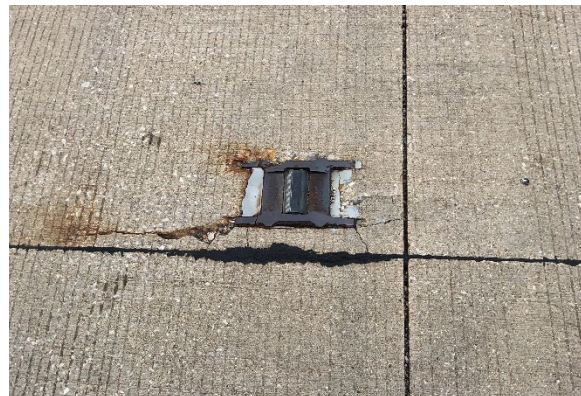
f) Distress from embedded raised pavement markers (multiple locations)

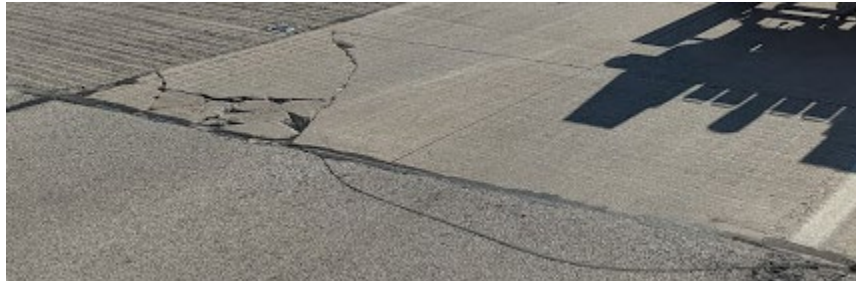
Figure 224. Photo. Distress photos of shattered slab in I-72 (72G92) EB.

- At the project start on the westbound, the left panel in the driving lane is shattered. This is likely from the construction process when starting the UBOL versus the existing HMA surface layer. This panel needs to be replaced with a full-depth repair.

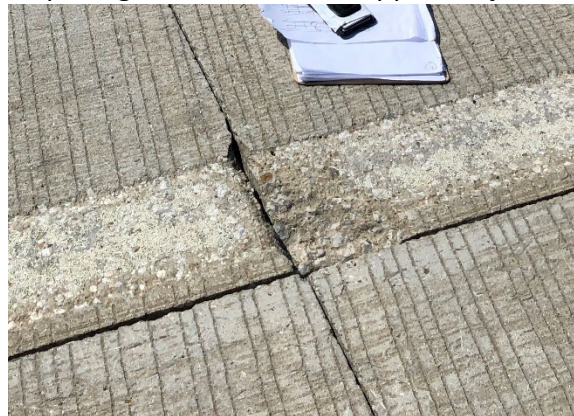
- All approach slabs have the distress shown in the figure below. It appears the milling head grinding performed for the rumble strips near the lane/shoulder joint, where the lane marking was painted, resulted in taking a chunk out of the approach slab. This can result in small corner spalls to eventually occur.

c) Milling of rumble strips effect on leave joint corner distress

Figure 228. Photos. Distress photos of improper milling on I-72 (72G92) EB and WB.

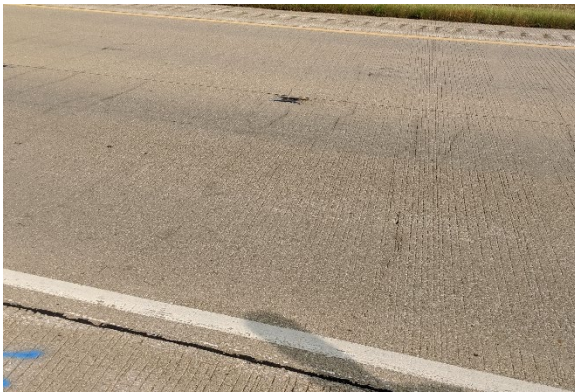
c) Y-cracking and cluster cracking (248+40 EB)

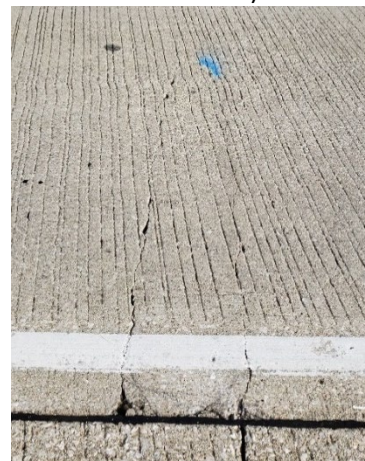
d) Y + Divided cracking (249+56 EB)

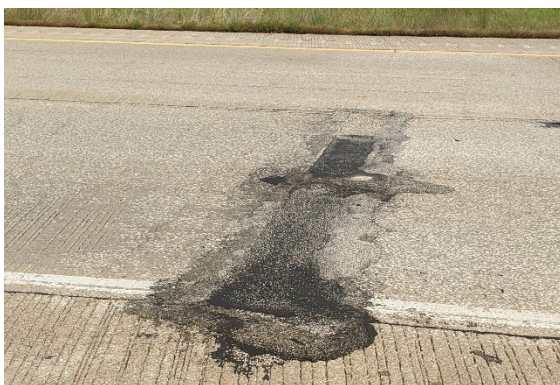
e) HMA Patch over punch-out (464+88 EB)

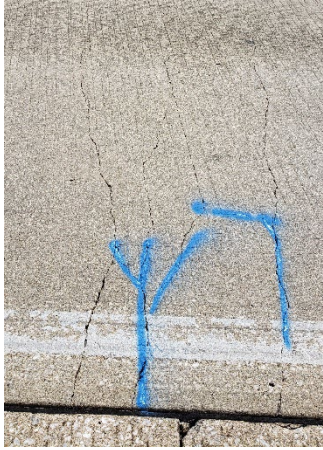
a) Complex Y-cracking (411+28 WB)

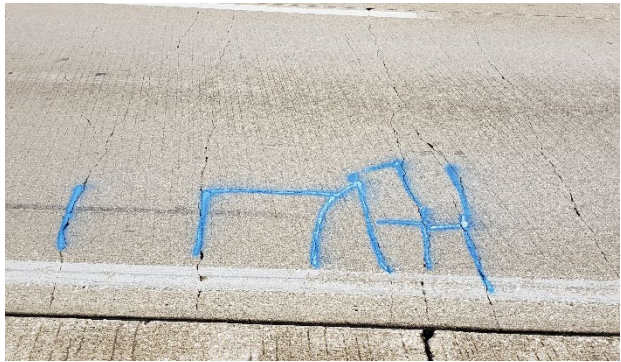
b) Complex Y-cracking (411+49 WB)

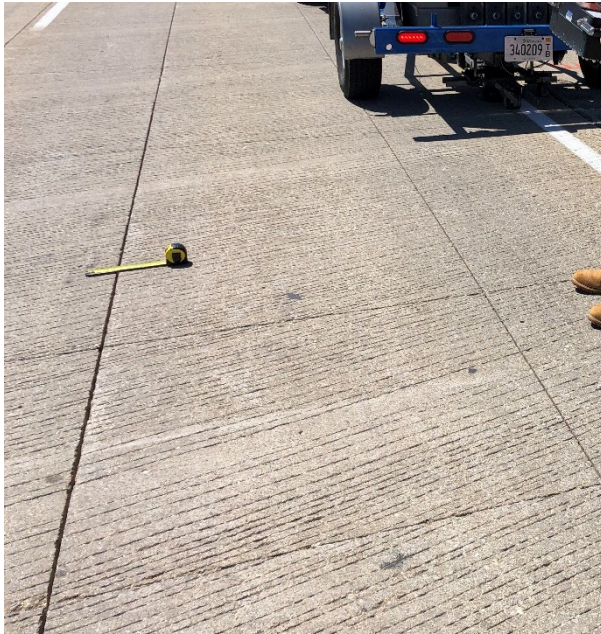
- The longitudinal joint in the inner wheel path of the driving lane was excessively wide (Sections 3 and 4) and was clearly activated. This was beneficial to be able to see joint activation of transverse cracks. However, because all joints are not sealed this will allow incompressible fine material and water to enter the system more easily and lead to more failures.

a) Long. jt in driving lane

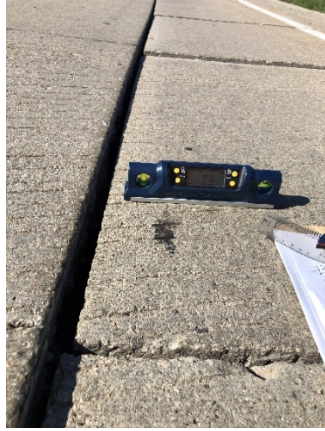
a) Severe long. faulting along OWP DL long. jt.

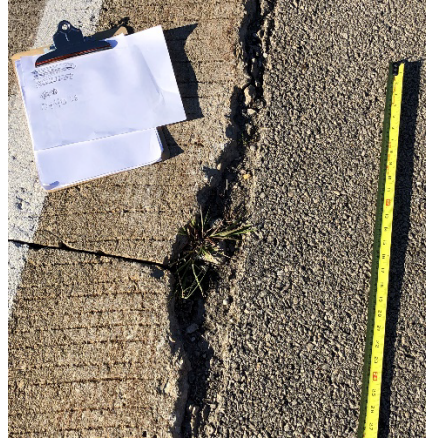
b) Lane/shoulder long. jt. degradation

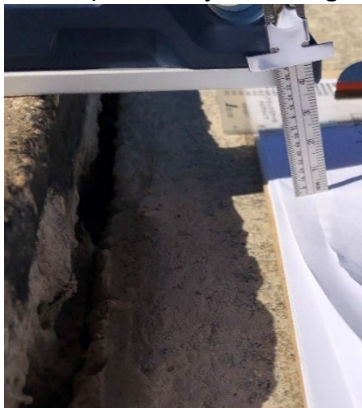
6+28 SB	Shattered slab in Passing lane
8+24 SB	Long. faulting (~0.35 in. [9 mm]); panel rocking
8+84 SB	Shattered slabs (four consecutive slabs) with HMA patching; panel rocking
8+96 SB	Long. faulting (1.8 in. [46 mm]) with corner break
9+48 SB	Shattered slabs (seven consecutive slabs) with HMA patching
11+12 SB	Scaling on surface of PCC (four consecutive panels)
Section 2 (61+00 SB)	
61+02 SB	Corner break (27-in. radius)
61+28 SB	Corner break with cracking and joint spalling (two consecutive slabs)

e) Long. faulting along OWP DL long. jt. (8+96 SB): ~1.8 in. (46 mm)

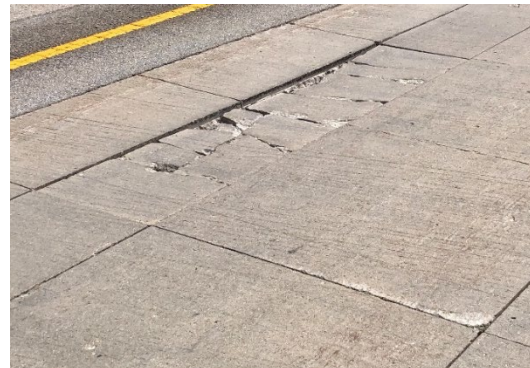
f) Additional Long. jt. causing cracking and punchout (similar to CRCP)

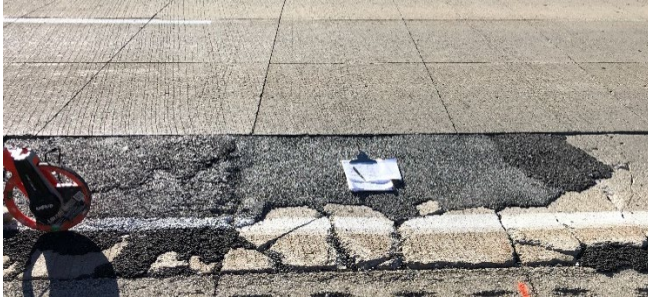
2+13 SB	Corner break on approach and leave slabs
2+27 SB	Shattered slabs (three consecutive slabs) with HMA patching; panel rocking
2+36 SB	Trans. cracking (two consecutive slabs)
2+56 SB	Trans. cracking (two consecutive slabs) with HMA patching; panel rocking
2+64 SB	Shattered slab (Corner breaks with long. crack across three consecutive slabs)
2+84 SB	Shattered slabs with HMA patching
3+52 SB	Shattered slabs in passing lane with HMA patching
3+72 SB	Corner breaks (eight consecutive slabs) with some HMA patching; panel rocking
4+24 SB	Long. faulting of 12 consecutive panels with HMA patching; panel rocking
4+61 SB	Corner break on approach slab
5+08 SB	Long. and corner cracking (eight consecutive slabs) with HMA patching; shoulder condition is poor in this location
5+40 SB	Long. faulting (five consecutive slabs); panel rocking
5+64 SB	Severe Long. cracking (eight consecutive slabs) with spalling along crack

a) Shattered slabs with HMA patching (2+27 SB)

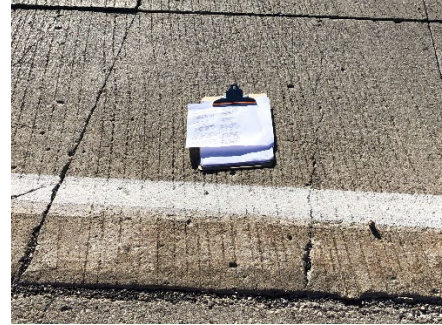
b) Trans. cracking (2+36 SB)

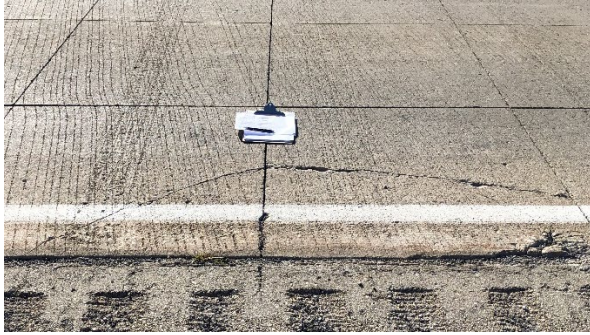
c) Slab cracking across three panels (L/S jt. edge)

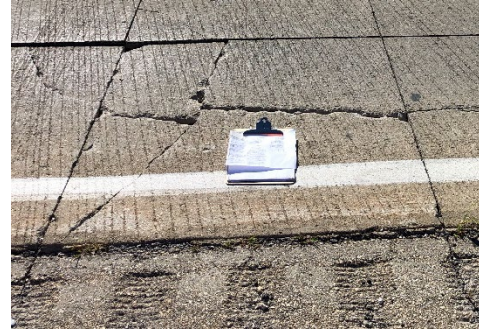
d) Shattered slab (2+64 SB)

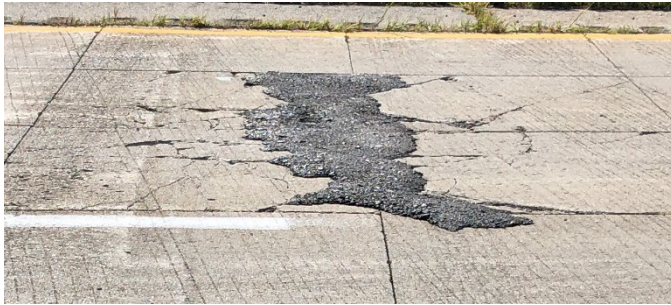
e) Shattered slabs in passing lane

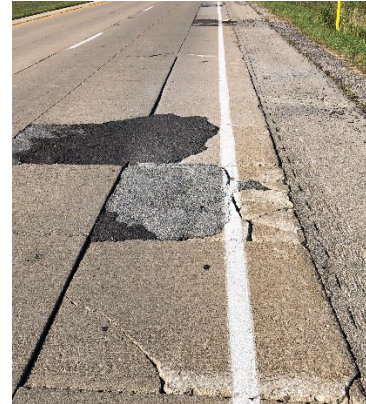
f) Typical observed failures in DL OWP

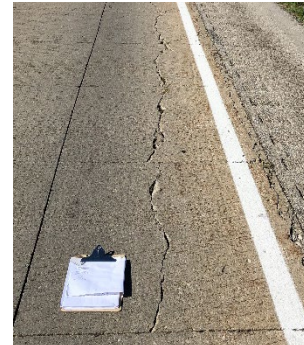
h) Severe long. cracking & corner breaks in OWP

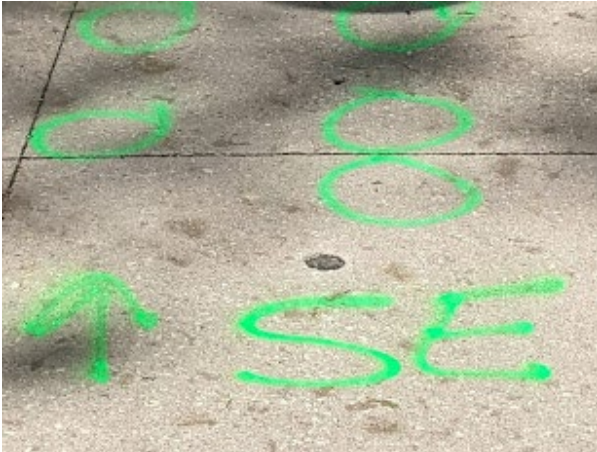
b) Fiber clumping and surface scaling in southeast bay
