Performance Evaluation of Stabilized Support Layers for Concrete Pavements

Research Report No. FHWA-ICT-22-003

ICT PROJECT R27-193-6

February 2022

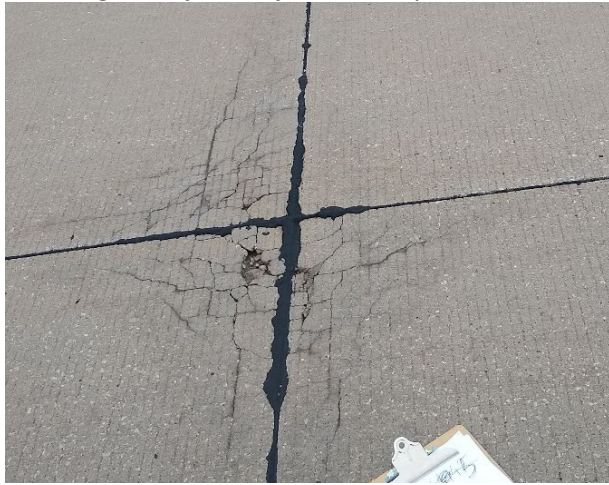
c) Corner distress in DL and PL (27+590 SB)

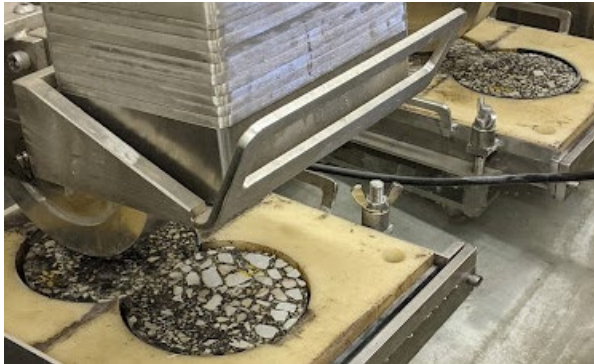
Figure 44. Photos. IL 53 BCOA Hamburg wheel-tracking device (HWTB) specimens.

Specimens 1 and 3 were obtained from the same location, center of panel at Station 61+10 SB (IL 53 Core #4). Specimens 2 and 4 were obtained from the same location, center of panel at Station 101+50 SB (IL 53 Core #6). Specimens 1 and 2 were the top lift of HMA (interface between PCC overlay),

whereas Specimens 3 and 4 were the second lift from the surface. The second lift from the surface failed drastically and can be observed in the following figures.

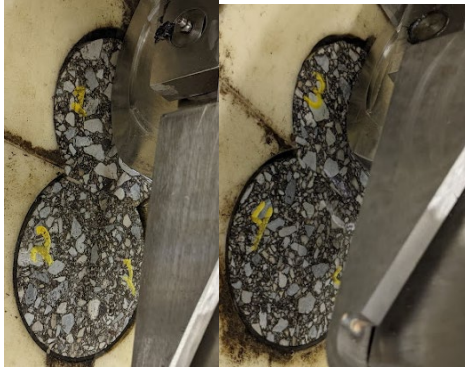
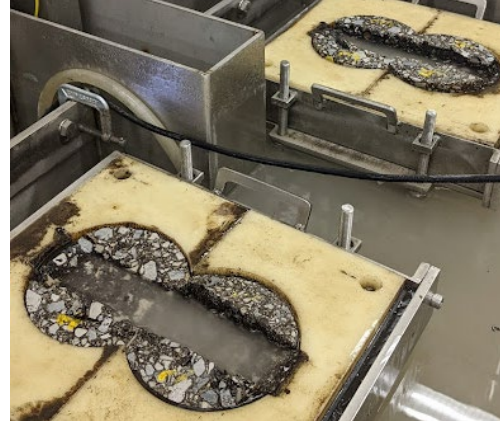
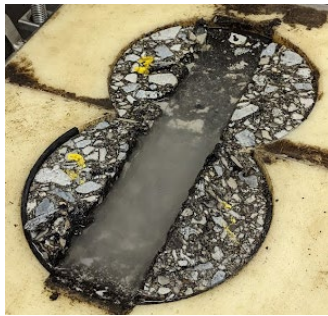
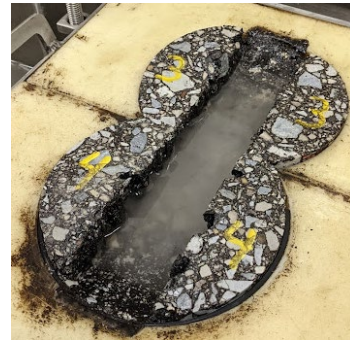
Figure 46. Photos. US 30 HMA subbase Hamburg wheel-tracking device (HWTD) specimens.

Specimens 1 and 3 were obtained from the same location, center of panel at Station 56+00 WB (US 30 Core #3). Specimens 2 and 4 were obtained from the same location, center of panel at Station 8+00 EB (US 30 Core #5). Specimens 1 and 2 were the top lift of HMA (interface between PCC), whereas Specimens 3 and 4 were comprised of the second lift from the surface or a different HMA mixture. This second lift HMA resulted in poor performance as compared to the HMA mixture at or close to the interface of the PCC.

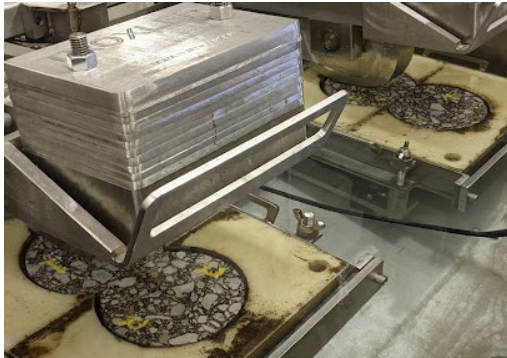
Figure 48. Photos. US 30 HMA subbase Hamburg wheel-tracking device (HWTd) specimens.

Additional testing was performed on other cores obtained from US 30. Specimens 1 and 3 were obtained from the same location, outer wheel path on the leave slab at the transverse joint at Station 95+00 EB (US 30 Core #2). Specimens 2 and 4 were obtained from the same location, outer wheel path on the leave slab at the transverse joint at Station 8+00 EB (US 30 Core #4). Specimens 1 and 2 were the top lift of HMA (interface between PCC overlay), whereas Specimens 3 and 4 were the second lift from the surface. The bottom of Specimen 4 was very erodible prior to testing.

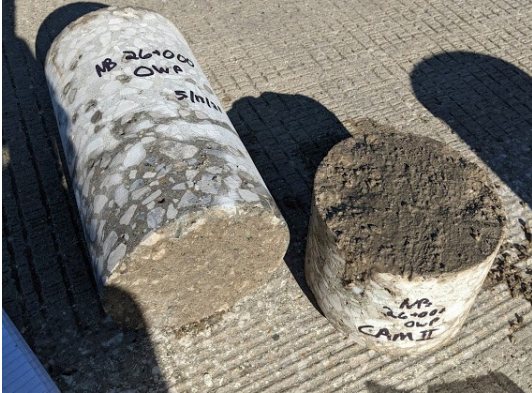
a) NB 26+000 Leave joint in outer wheel path

NB/SB	Stationing		Location	PCC Thickness, in.	Subbase Thickness, in.	Additional Observations
NB	26+000	1	LJ OWP	10.25	4.25	Debonded, Delamination in core hole; some possible erosion
		2	Center	10.125	4.5	Fully bonded
NB	28+600	3	LJ OWP	10.125	4.5	Debonded with smooth interface, No observable erosion; delamination in core hole
		4	Center	10.0	3.5	Fully bonded
SB	26+600	5	LJ OWP	10.0	3.5	Debonded with significant erosion, No cracking or faulting
		6	Center	10.0	4.0	Debonded, Delamination at interface in core hole; no observable erosion

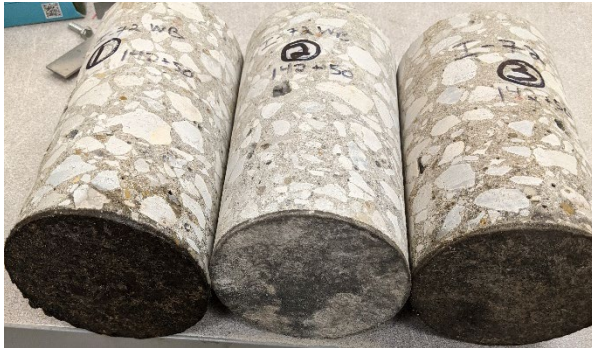
a) 142+50 WB cores: Fabric intact

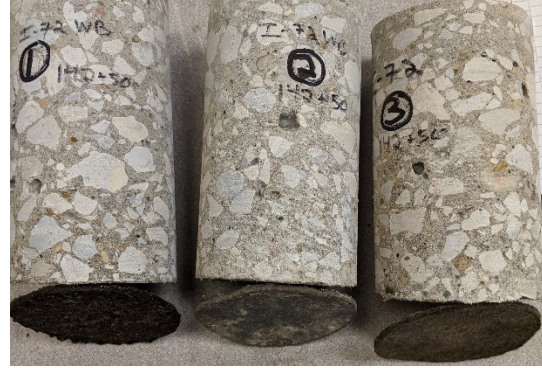
b) 142+50 WB cores: Fabric removed

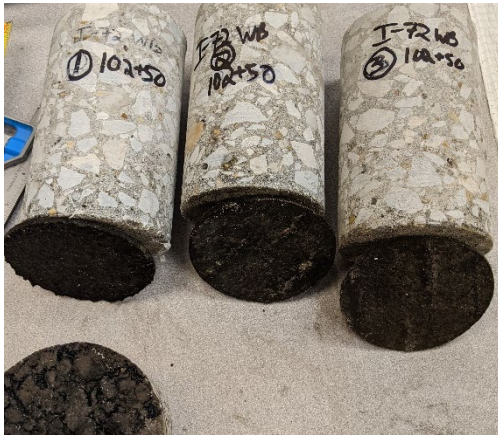
c) 102+50 WB: Fabric removed with existing HMA present

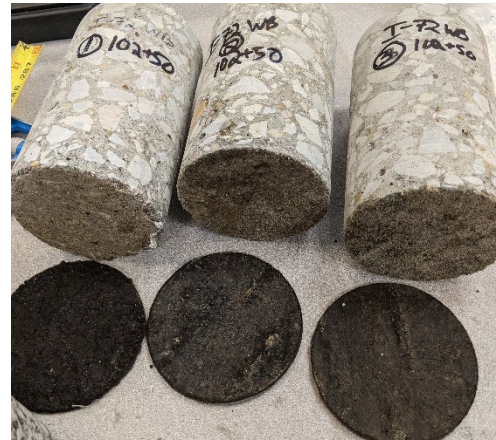
d) 102+50 WB: Fabric removed

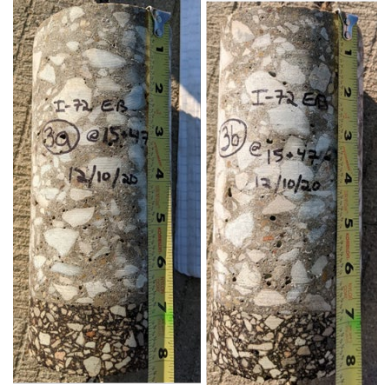
Right edge panel (Leave slab): NOT in wheel path

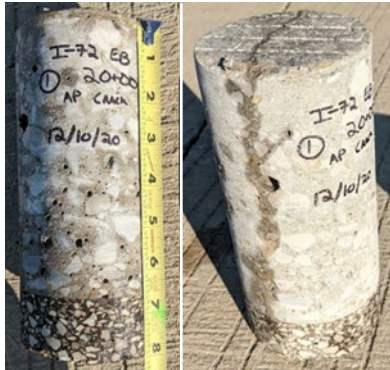
All cores showed a bonded condition between the bottom of the PCC overlay and the HMA interlayer. There was no bond present between the bottom of the HMA interlayer and existing CRCP. The cores over the longitudinal cracks in the wheel path were held very tight due to the engaged fibers. In order for the crack to be visible, moisture needed to be present (see **Figure 196a** and **b**). Unfortunately, there was no visible permanent deformation in the wheel path versus non-wheel path. An interesting phenomenon occurring at the core locations over the longitudinal crack in the wheel path near the

Outer wheel path (approach joint): Over longitudinal crack

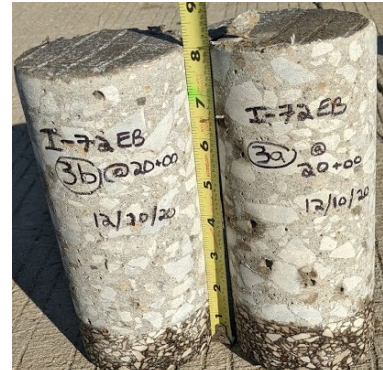
Right edge panel (Leave slab): NOT in wheel path

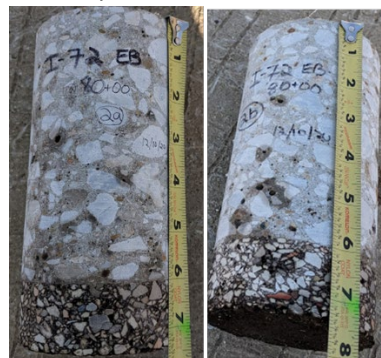
Outer wheel path (approach joint): NOT over longitudinal crack

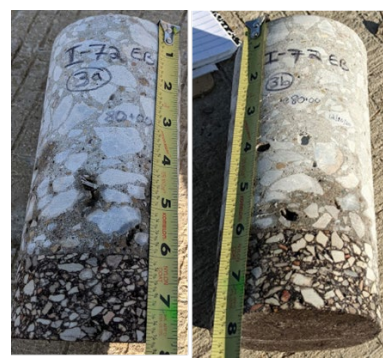
Right edge panel (Leave slab): NOT in wheel path

Figure 196. Cores from I-72 (72G92) EB taken in 2020 (no longitudinal crack in Location 3: 80+00 EB).

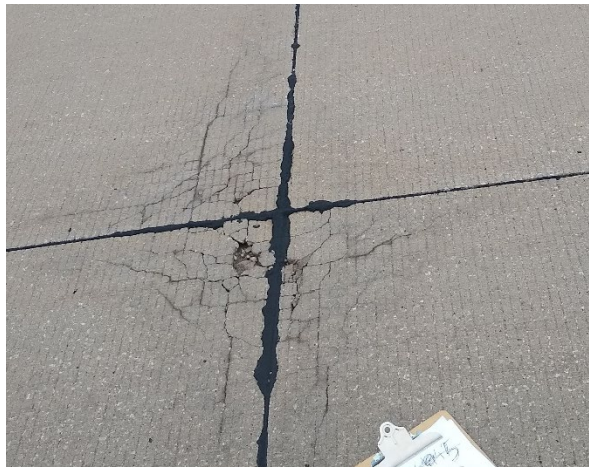
c) Corner distress in DL and PL (27+590 SB)

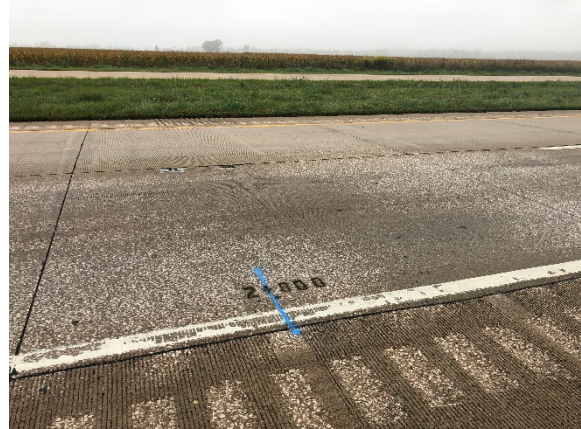
b) Surface diamond ground (2+800 WB)

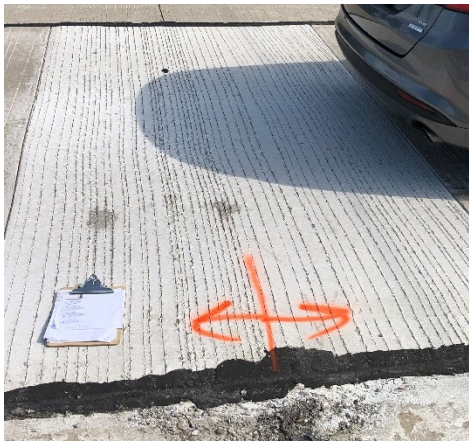
c) Full-depth repair (70+30 EB)

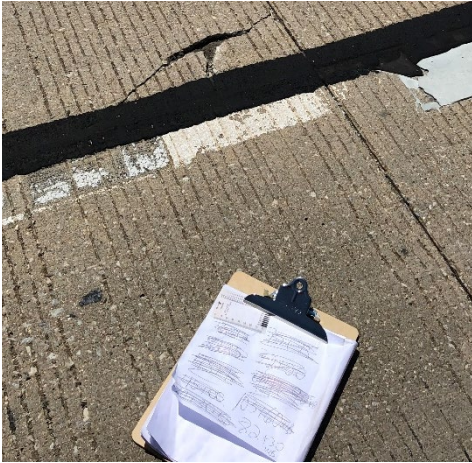
c) Corner distress in PL (82+30 WB)

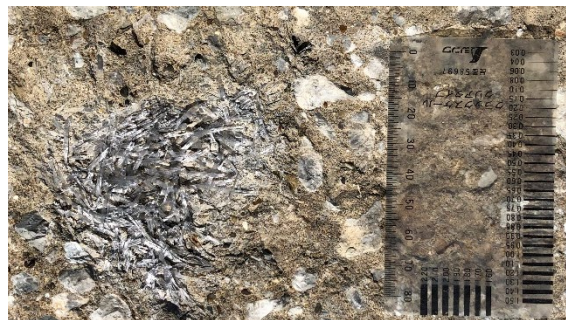
Figure 225. Photos. Clumping of fibers in I-72 (72G92) EB.

- Clumping of the fibers were observed once. It appears the mixing was done very well and fibers were distributed evenly throughout concrete material production and construction.

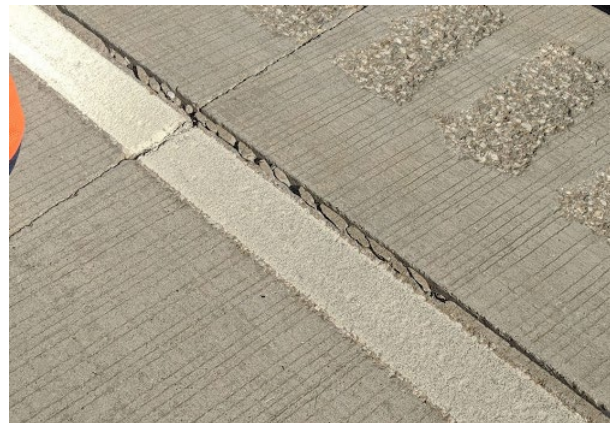
b) Potential distress occurring from elevation difference

Figure 226. Photos. Distress photos of longitudinal faulting in I-72 (72G92) WB.

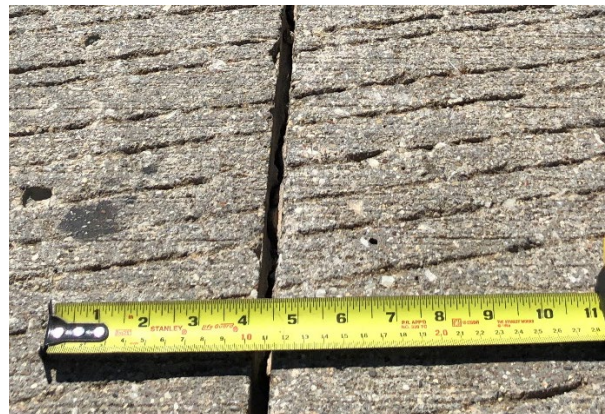
- The longitudinal joint in the inner wheel path of the driving lane was excessively wide (Sections 3 and 4) and was clearly activated. This was beneficial to be able to see joint activation of transverse cracks. However, because all joints are not sealed this will allow incompressible fine material and water to enter the system more easily and lead to more failures.

b) Long. jt in driving lane ~0.5 in.

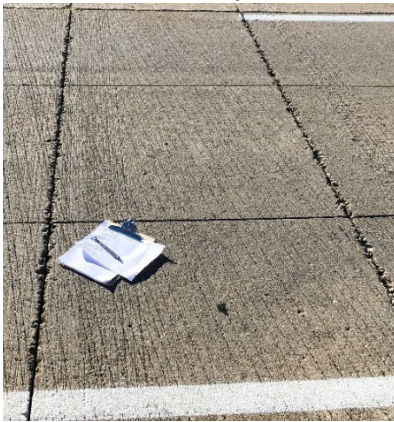
c) Trans. jt. ravelling

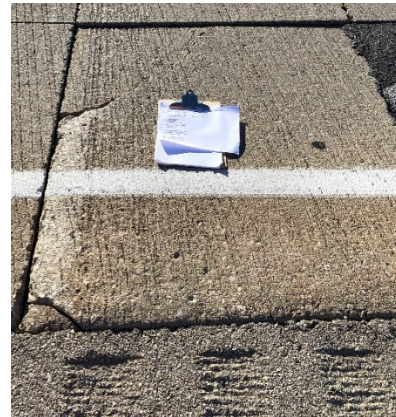
d) Corner breaks and distress

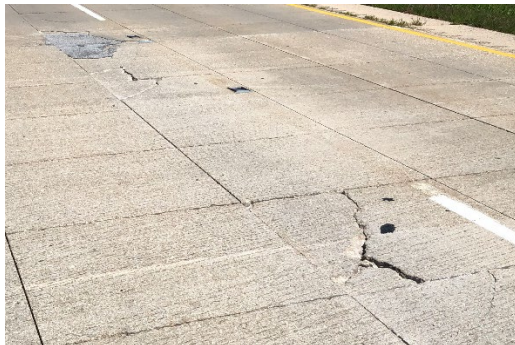
g) Corner breaks in IWP of DL

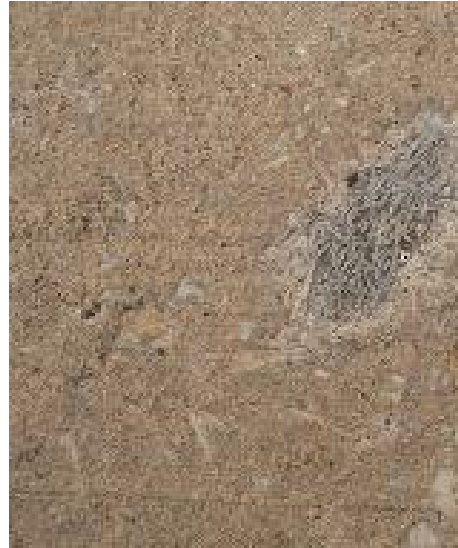
The overall condition of E-15 is excellent and not much has changed since the previous surveying and testing performed in 2012. The major distress present consisted of fiber clumping near the surface, causing small pop-outs. Some scaling is also apparent in the traveling lanes in the eastern section. Previous reports indicated areas of debonding were found mainly near the construction joints (King and Roesler 2014), however no indication of debonding was visually apparent during the current surveying. Additional cracking present was documented during the previous survey and included low severity cracks (corner breaks and diagonal cracks) near islands or propagated from drains.

b) Fiber clumping
